FROM YOUR OWN CORRESPONDENTS

Updates from Cornwall Archaeological Society's Area Representatives

AUGUST 2022

Issue 69

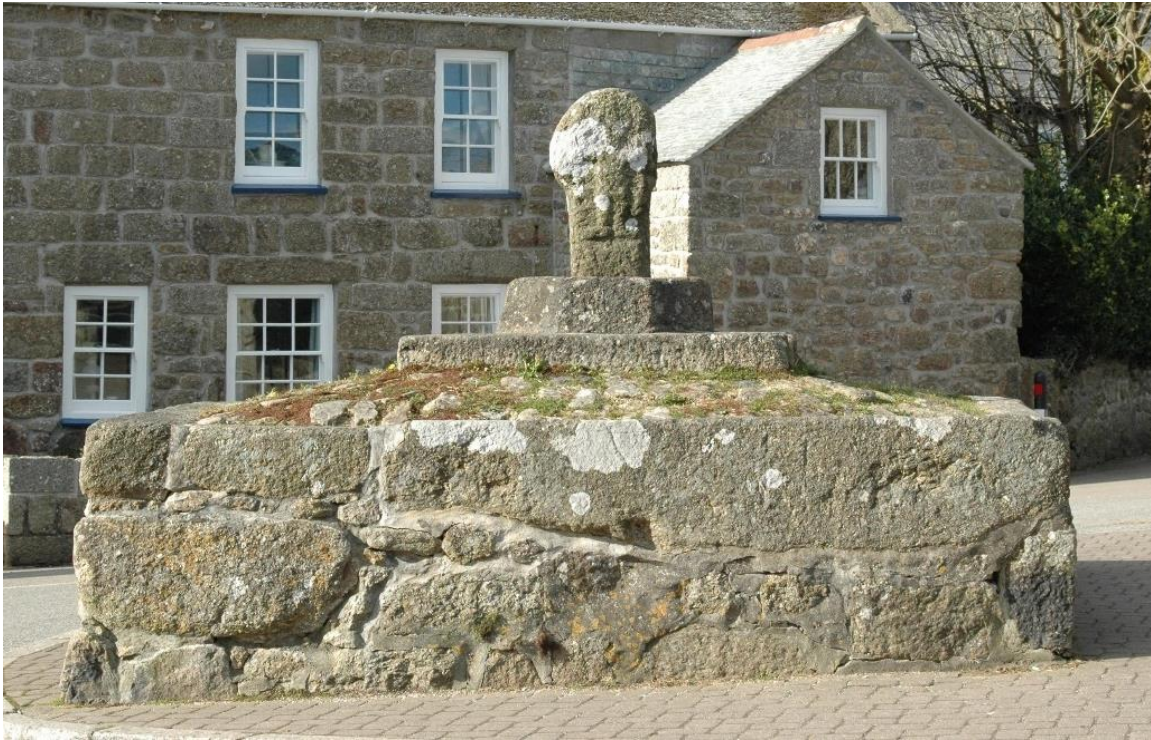
St Buryan Churchtown Cross before recent damage, Photo: Ann Preston-Jones

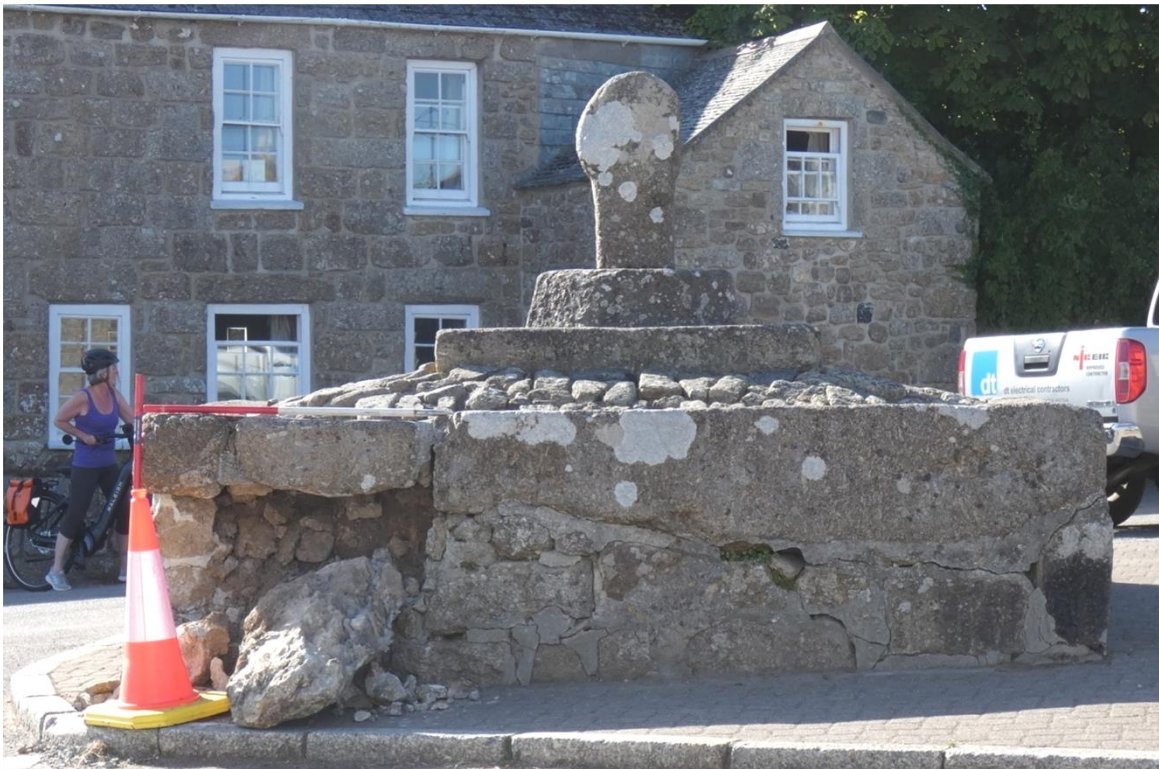
On Tuesday 9th August a delivery lorry hit the stone platform supporting the St Buryan Churchtown Cross, which stands close to the south gate of St Buryan parish church. A large granite stone has been dislodged and has fallen out of the wall and this has caused other stones and the rab fill to fall from the platform. The driver allegedly attempted to leave the village after the accident without reporting it, but was challenged by local people and the company's name and address was obtained for insurance details.

The raised platform almost creates an island in the centre of the village, at a junction with the B3283 road through the village and a minor road which skirts around the west side of the churchyard. Although the damage is not extensive, it will still take time and money to complete a sensitive repair. This monument has been damaged by vehicles on several occasions, the last was in 2007.

St Buryan Churchtown Cross showing damage to the SE side of the platform,
Photo: Andrew Langdon 9 August 2022

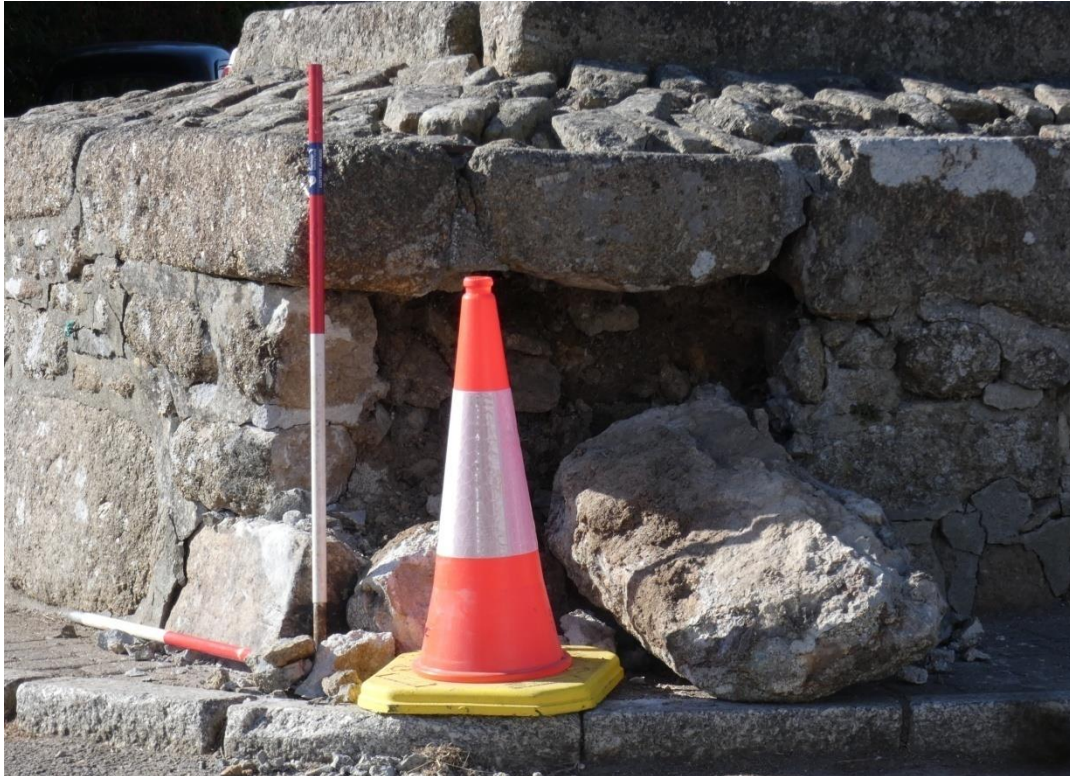
St Buryan Churchtown Cross, showing closer view of the damage.

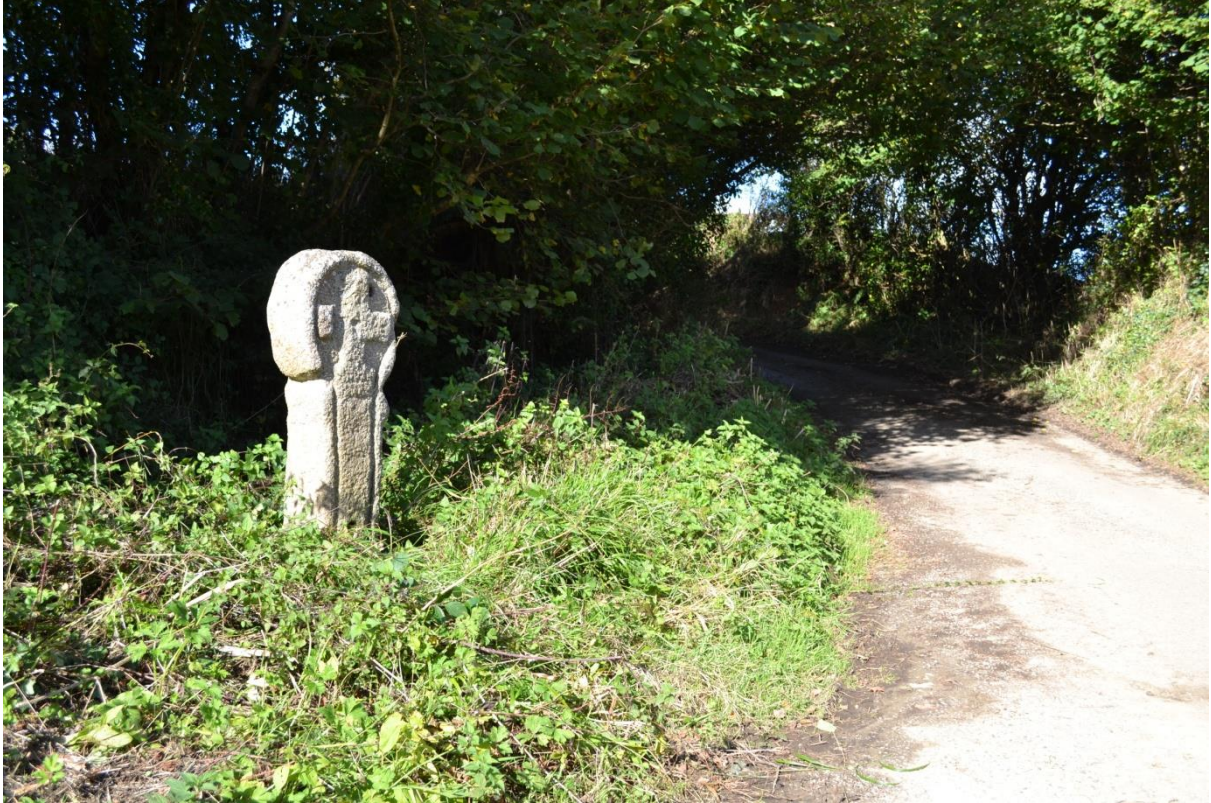
Trevalsa Cross in 2005 after restoration of the cross-head. Photo: Ann Preston-Jones

This cross will need to be re-pinned to its base-stone and the former repair to the wheel-head assessed and made good.

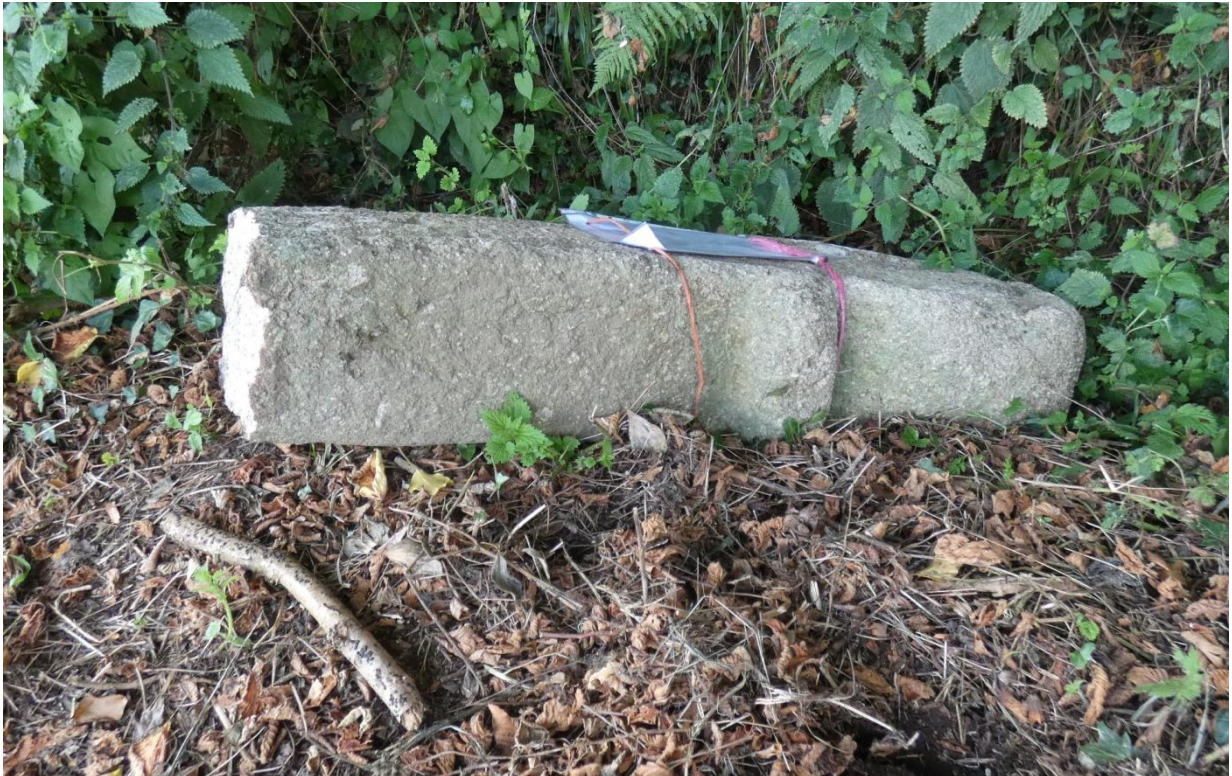
On Thursday 25th August 2022, I received a text message and photographs showing that the joint in the cross-head had become more noticeable, and on visiting the monument the following day I found that the cross was only being held in place by gravity, having been fractured at the bottom of its shaft, where it is fixed into the base-stone. It appears that whoever damaged the cross, left it propped it up for someone else to discover, a rather dangerous thing to do, considering the weight of the monument. As the cross was beside the highway Cormac were notified and their staff came out and laid the cross down in the drainage ditch awaiting restoration.

Trevalsa Cross fractured and lying down. Photo: Andrew Langdon

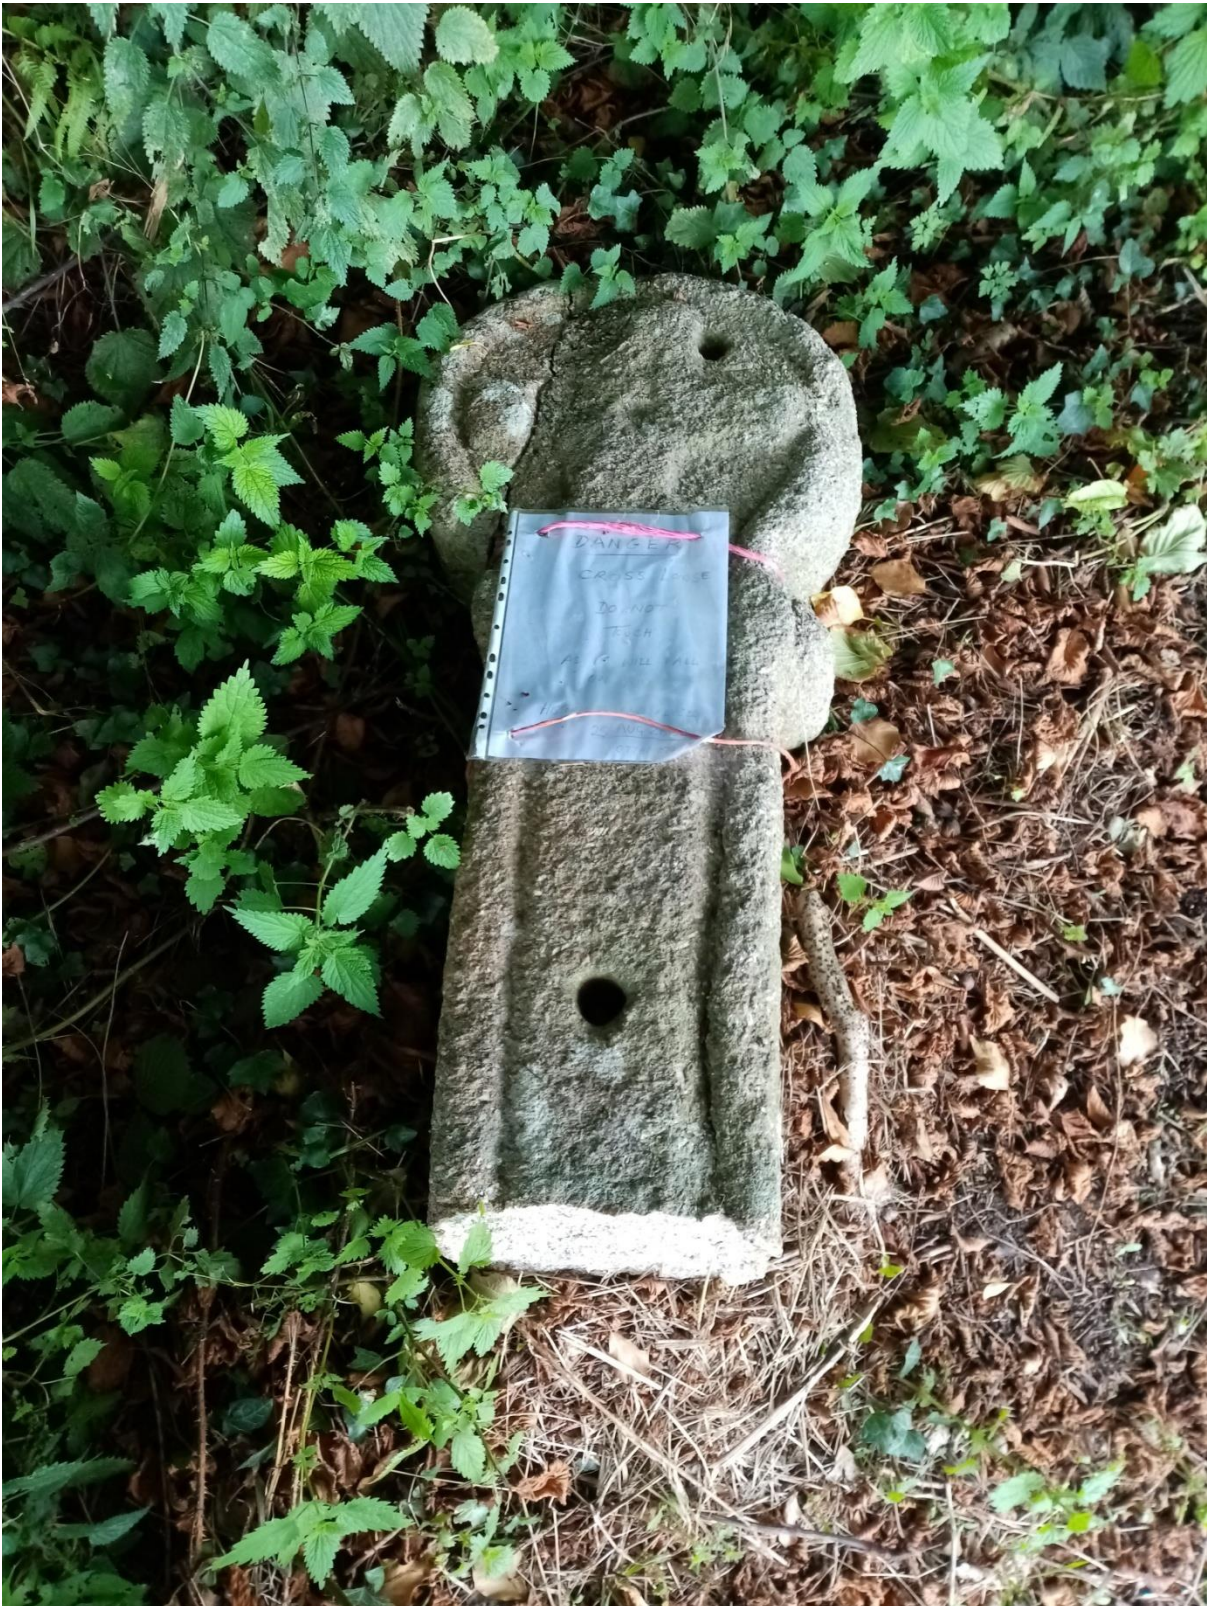
Trevalsa Cross with notice stating that the cross was fractured and may fall on someone.

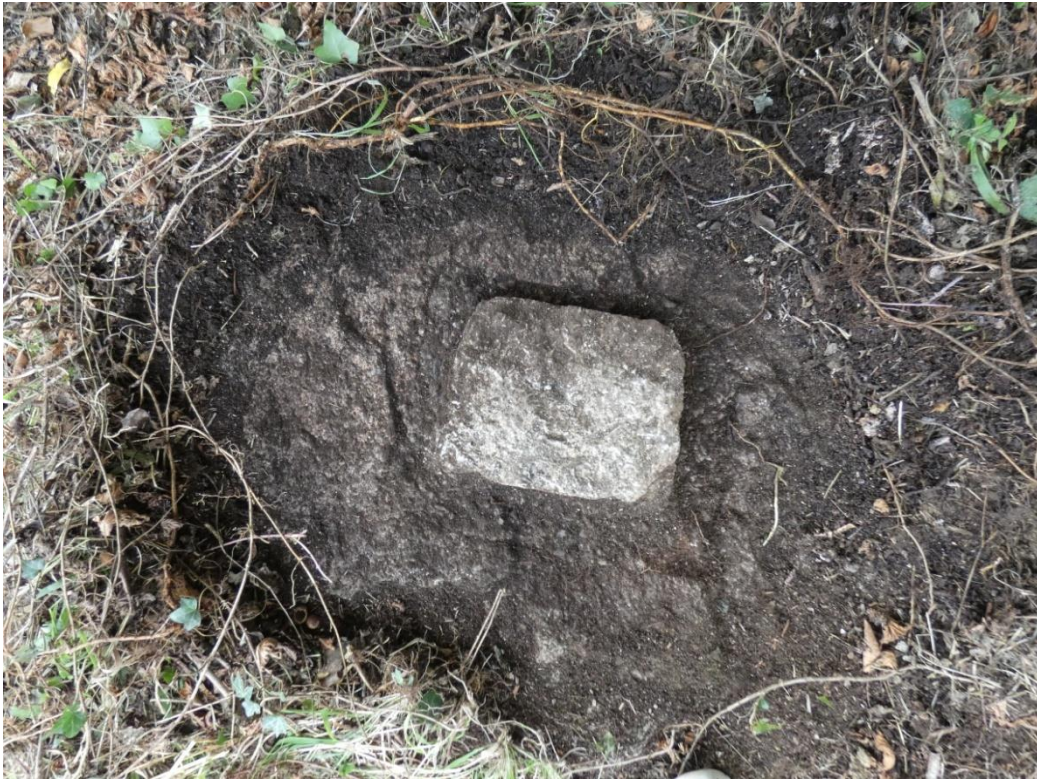
This photograph shows the bottom of the shaft snapped off at the base-stone.

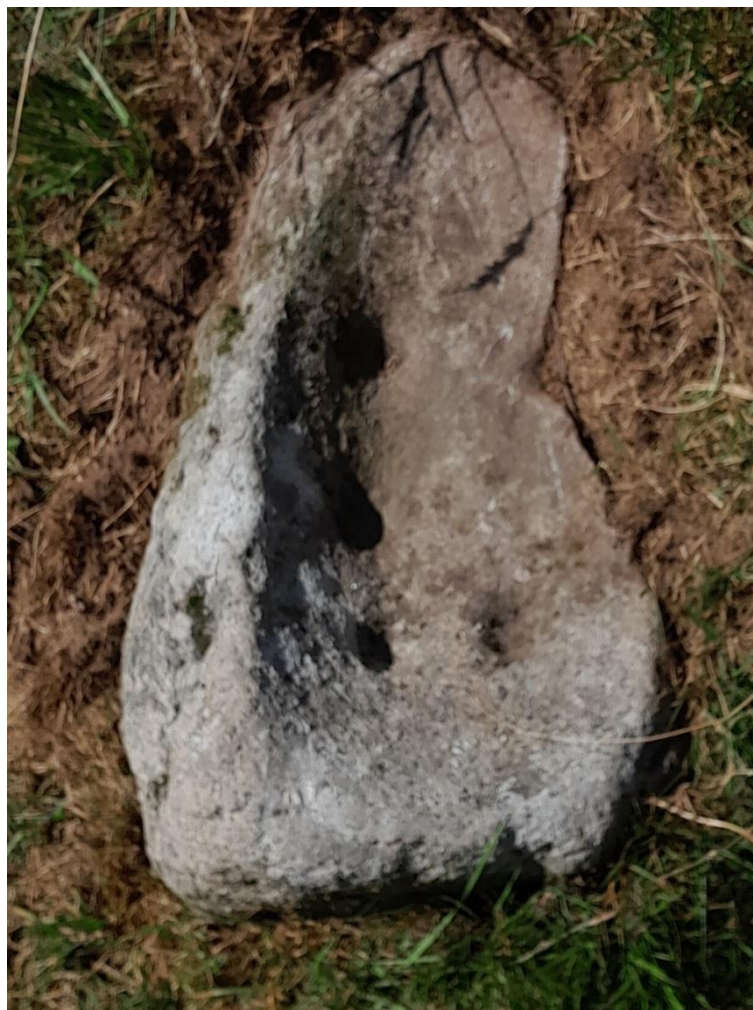
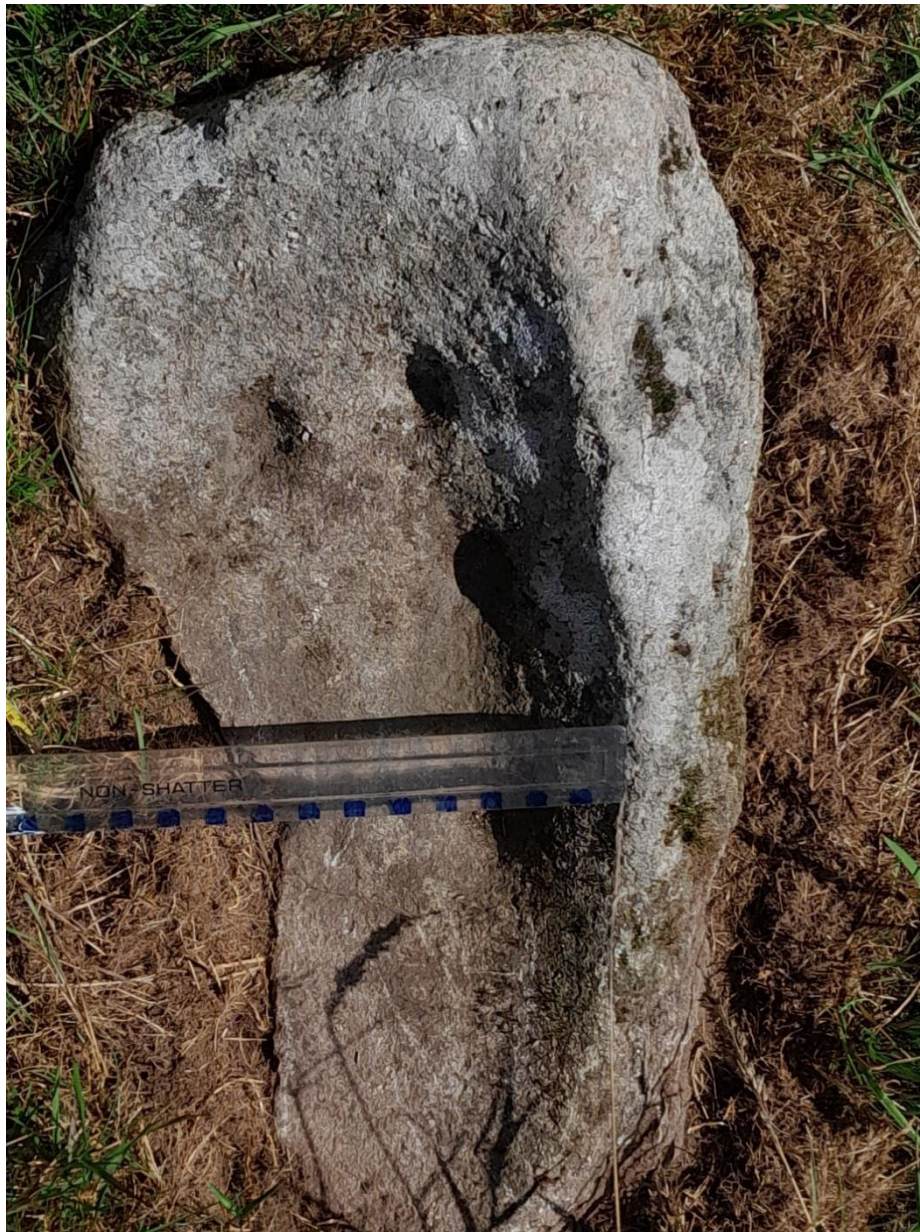
The mystery stone

The stone is 52cms long. 13cms wide at its narrower end and 23cms at the widest part, rounding down to 20cms. The depressions are roughly 2cms deep, 3-4cms wide and the three in the vertical line are spaced 13cms, top to middle, then 10cms. The horizontal depressions are 8cms apart. The stone apparently fractured when two other depressions were made, the top one in line with the top existing depression and another horizontally in

Stone with scale

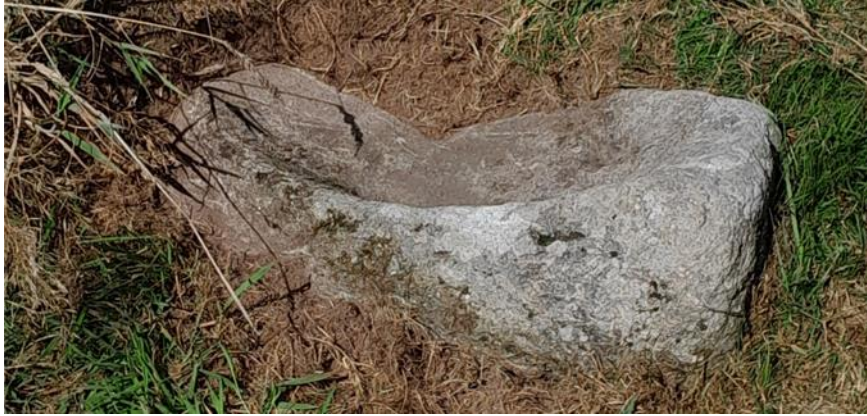
That it was a recycled saddle quern is suggested by its shape and smoothness. The exposed granite at Chysauster is smoother than the Land's End granite.

Quern stone

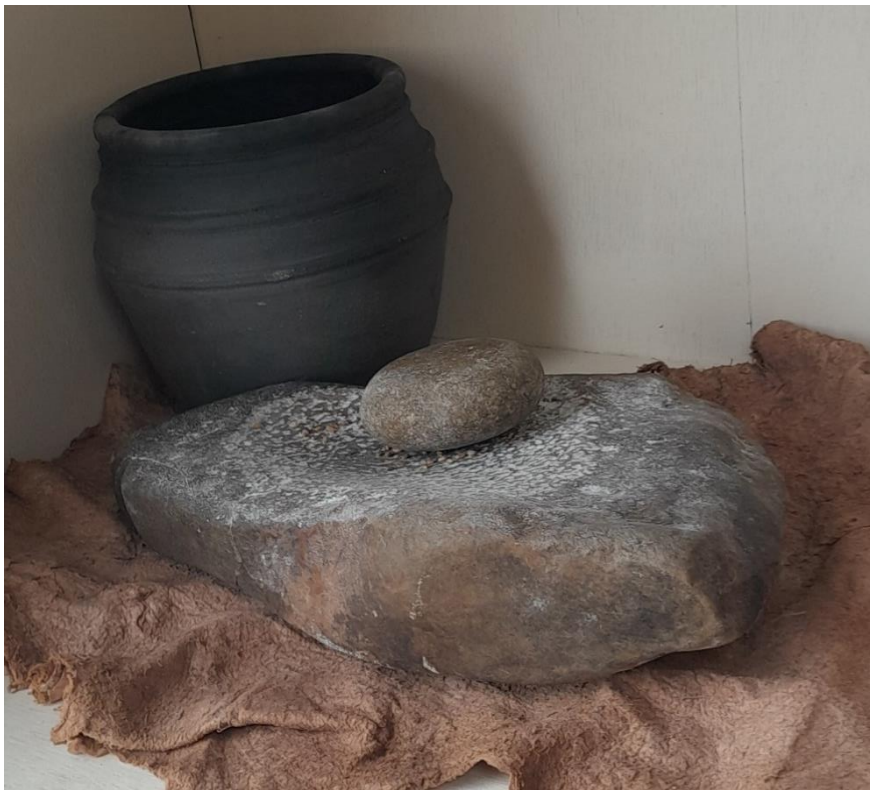
Saddle quern and muller from the Chysauster handling collection

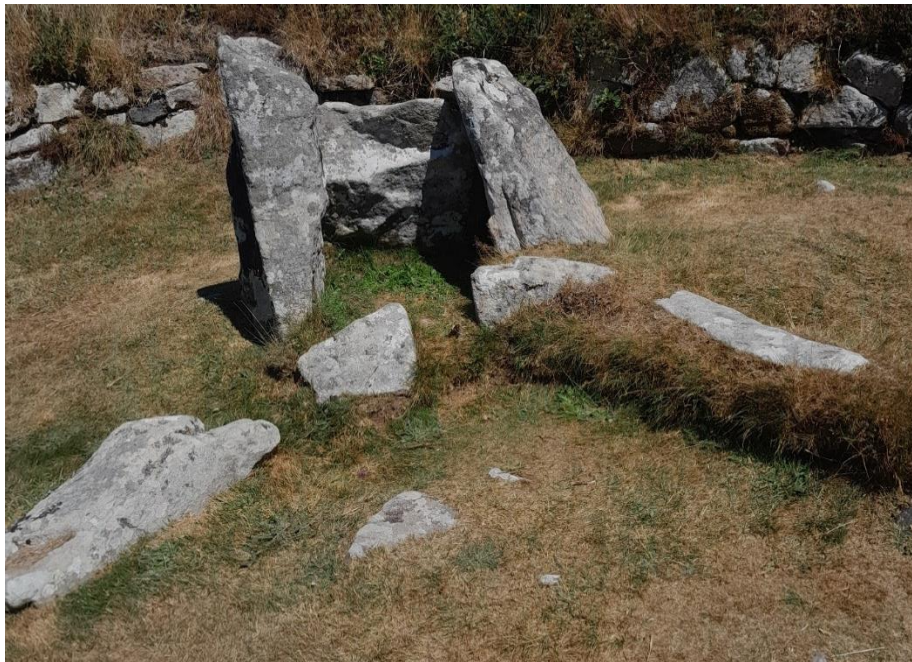
The "furnace" at Chysauster

A structure in house 3 at Chysauster gives the appearance of a hearth or forge, but excavations revealed no signs of intense burning (EH Guide to Chysauster and Carn Euny). A granite weight found in House 3 was probably intended to weigh quantities of tin for trading. Pebbles of cassiterite were found at both Chysauster and Carn Euny, a lump of tin and other fragments of metalworking waste was found in House 6 at Chysauster. W C Borlase found fused tin inside the fogou passage at Carn Euny in 1863.

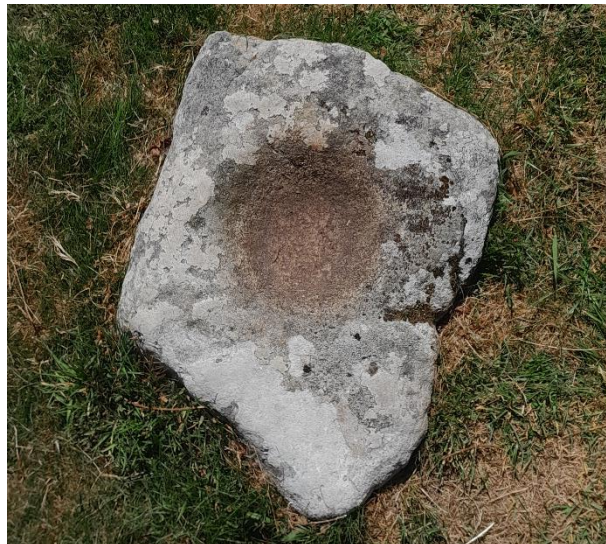
This does not describe the shape of an ingot from in our pitted mould, which would come out like a bun or loaf with rounded protuberances. There are small round bottomed depressions in stones at both courtyard settlements of Chysauster and Carn Euny, which might have been for processing cassiterite, the tin oxide, by crushing it to separate the ores. They may have been small moulds or they may have been bases for wooden roof supports.

Worked stone at Chysauster. Bun mould or mortar for cassiterite? Photo: Adrian Rodda

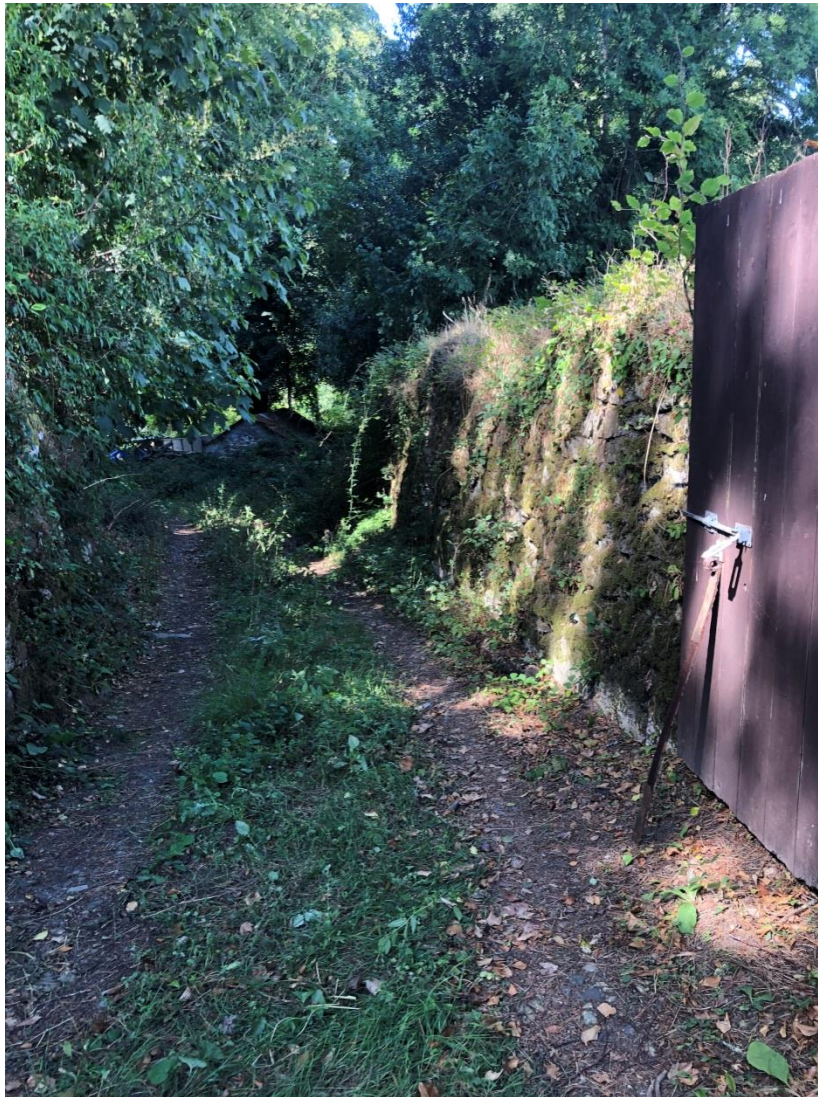
Site entrance

So this plot was clearly an important part of this very significant industrial complex. What did Tracy find during her monitoring visit? Tracy noted: *'The storage complex includes a triangular shaped distribution yard with four 19th century gunpowder magazines. The yard is separated from the main gunpowder production facilities (a separate HE listing) for safety reasons. There are three large magazines essentially similar in construction and size and situated in a row. There is a fourth smaller store situated across the yard.'*

The three main magazines appear to have deteriorated since the 2000 Listing. Two were described as having largely intact roofs but this is not now the case. It was not possible to get close to the buildings nor to enter but they are supporting a lot of ivy and there is tree

growth inside at least one (the middle of the three). The smaller store still fits the description in the list entry but the corrugated iron roof has gaps or missing sheets.

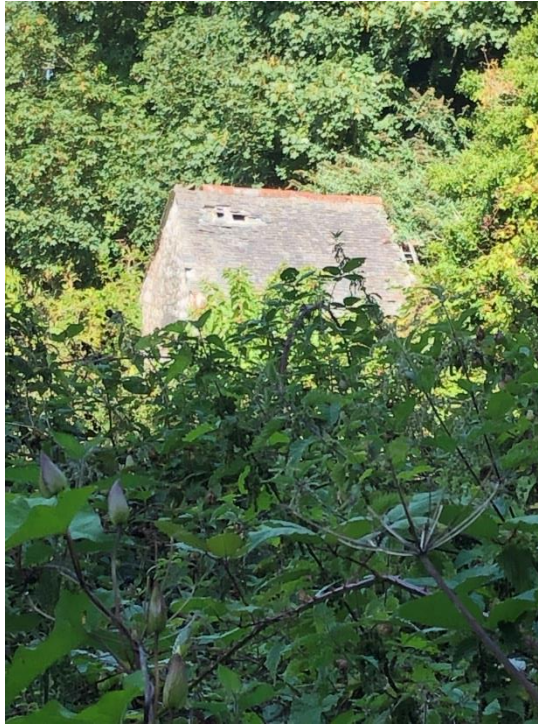
HER 1020441 Right hand magazine Photo: Tracy Dearing

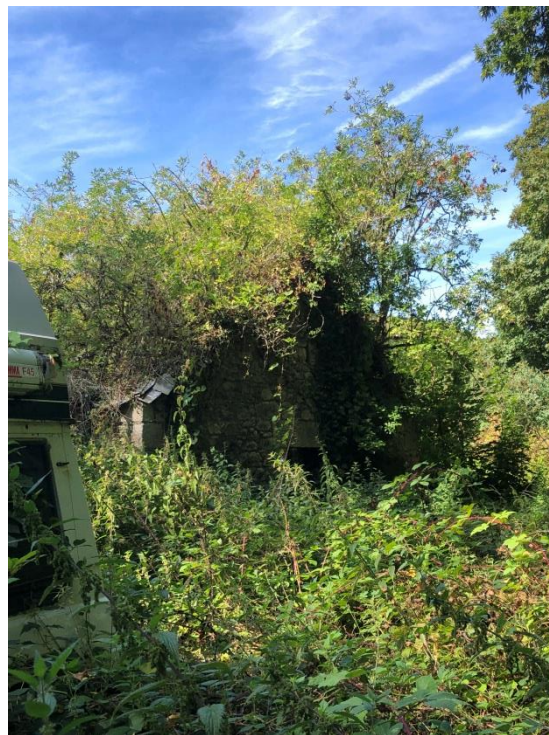
HER 1020441 Middle magazine Photo: Tracy Dearing

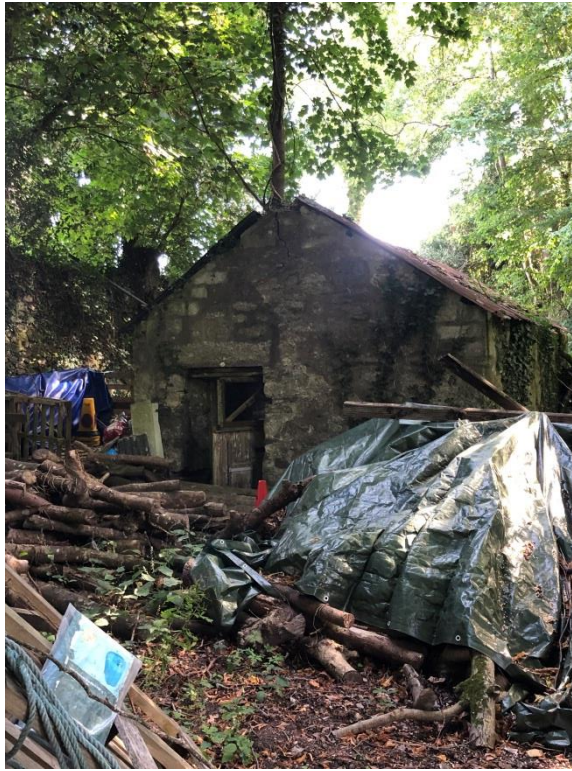
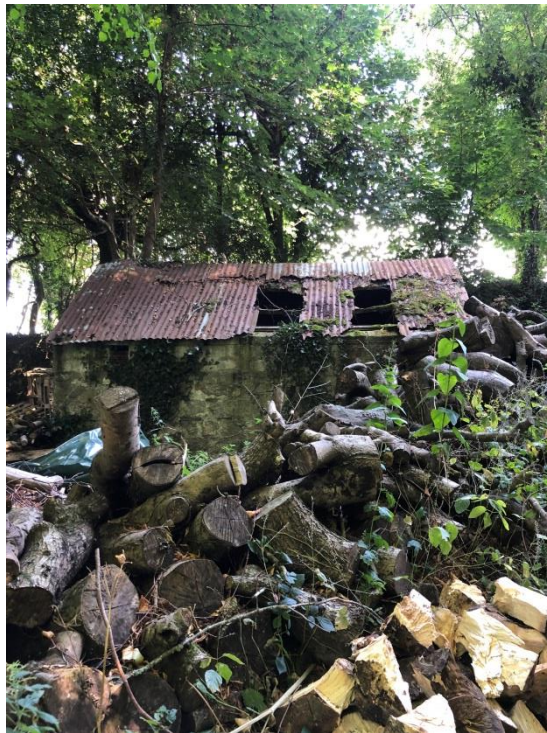
HER 1020441 Small magazine

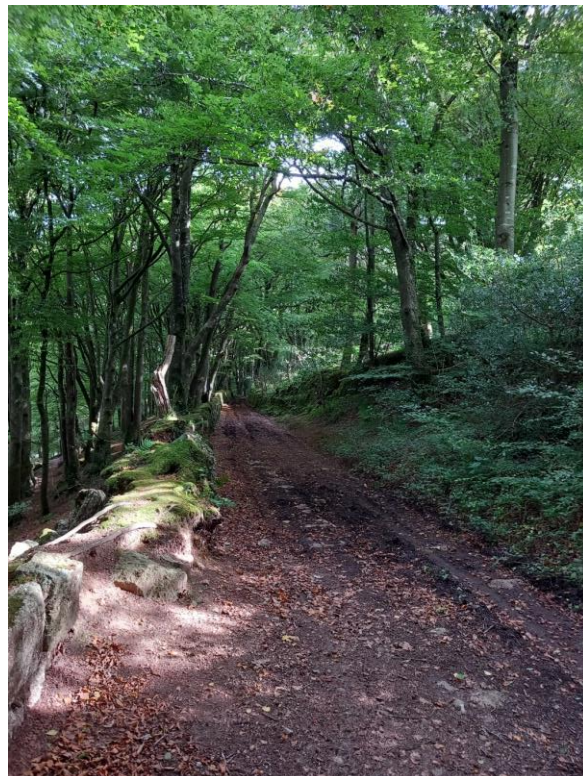
Recently someone has been dislodging stones from the top of the wall and pushing them down the steep slope where they end up in the Fowey Consols Leat.

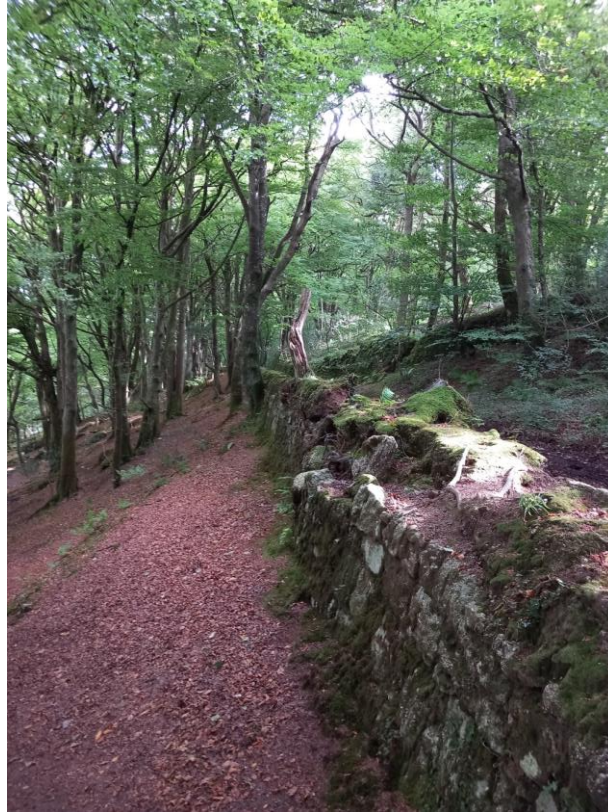
Note the steepness of the slope to the left of the wall.

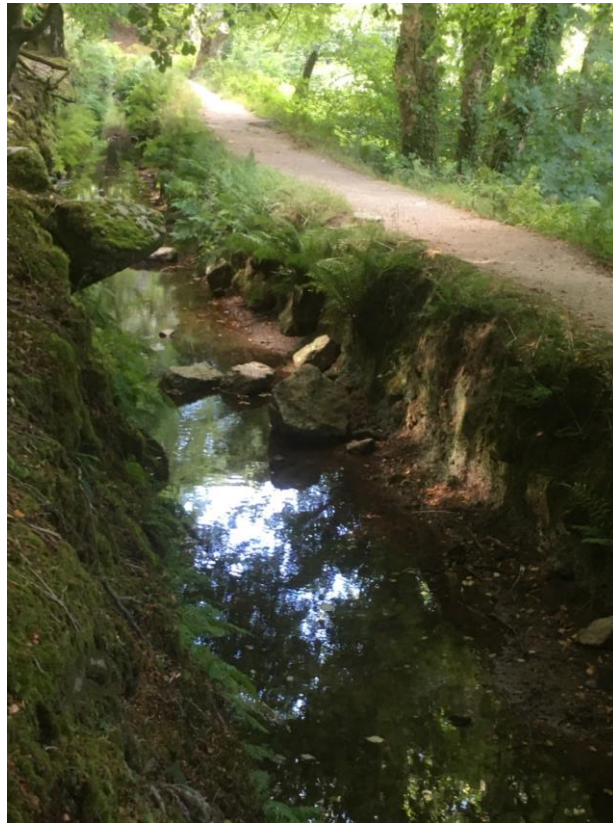
Fowey Consols leat with stones

This has been reported to the police as a heritage crime but it is also worrying because if anyone was caught in the path of these large stones serious injury or death would inevitably result. Children would not have the strength to move them from the wall so the perpetrators must have been older. It is impossible to remove the stones from the leat manually because of their weight and a mini-digger cannot get to this section of the leat path. Work has been going on recently to restore the leat but these stones will inevitably affect the flow of water.

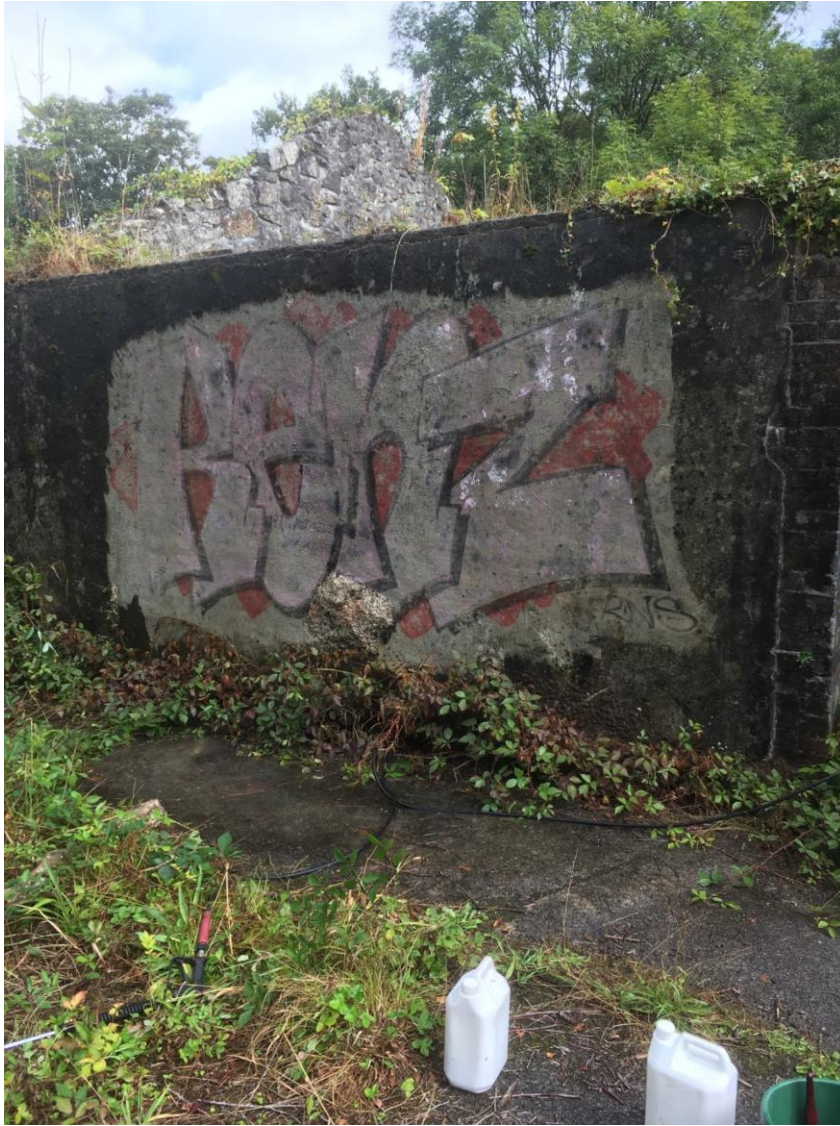
Towards the southern end of the Valley, a different sort of vandalism has been sorted out very quickly. Jenny Heskett was alerted to graffiti on one of the walls of the Central Cornwall, or Trevanny, china clay dry (HER 9050; SX 0659 5626; Luxulyan parish) and swiftly arranged for it to be removed.

Graffiti tag after pressure-washing

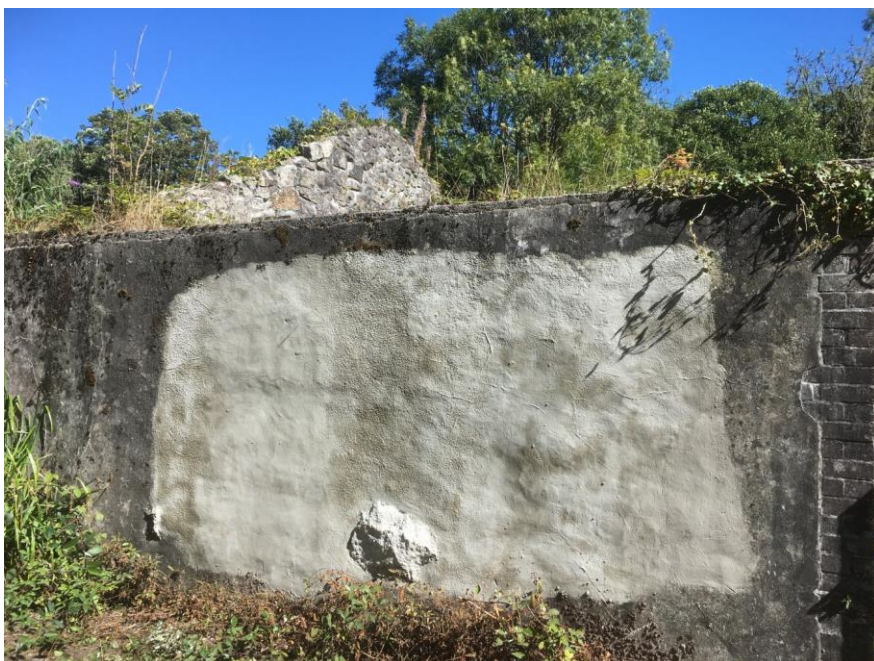
Success!

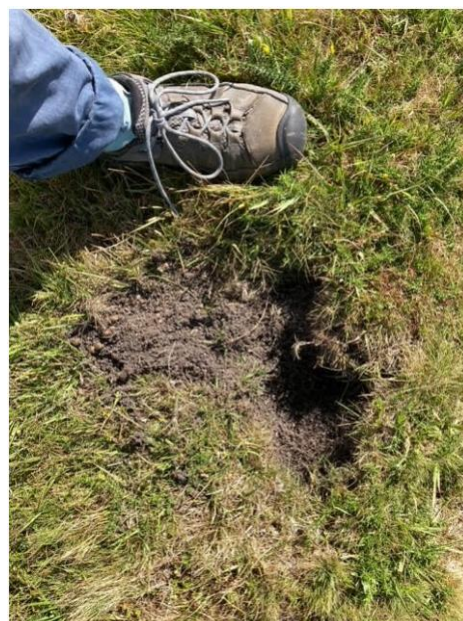
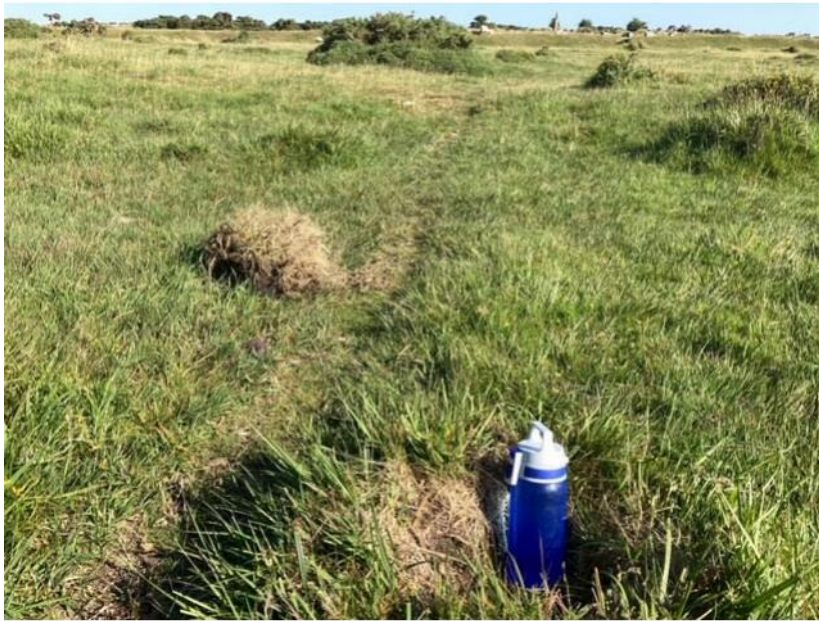
The holes haven't been the regular round shapes noted in early editions of this newsletter but are narrower, deeper and sometimes irregular in shape. Only one had partial replacement of turf, the others had no turf in sight.

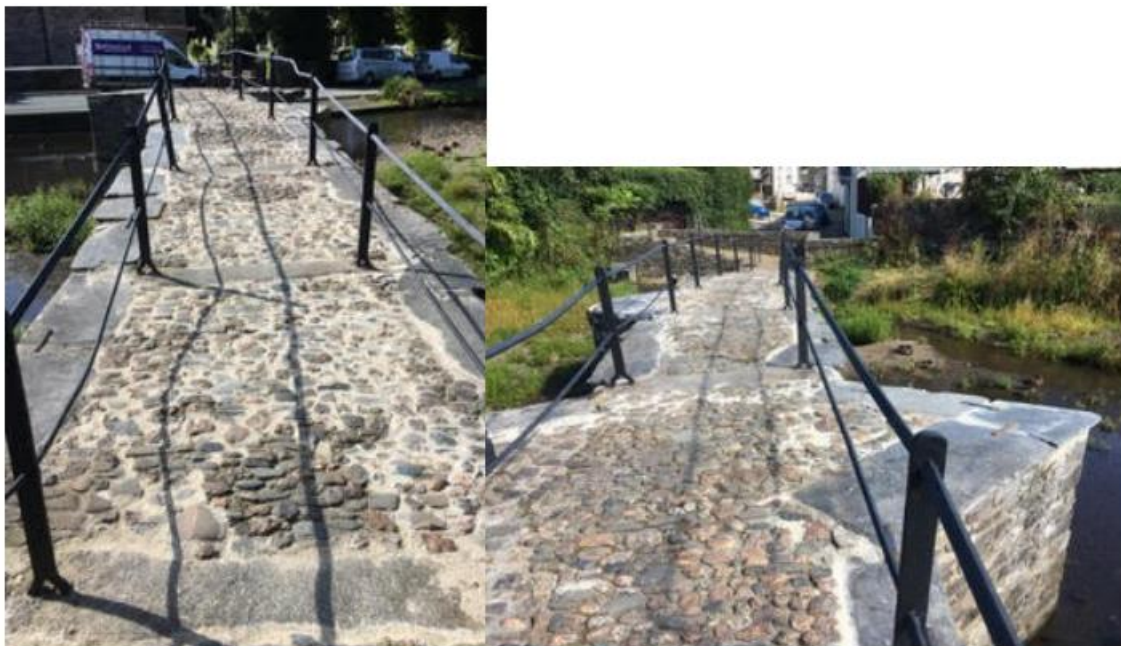
Photos: Peter Crispin

Peter Crispin has sent photos of the lovely restoration of the Prior's Bridge near Launceston (HER 2612; Scheduled Monument 15571; Listed Building (I) 370137; SX 3278 8509; Launceston parish).

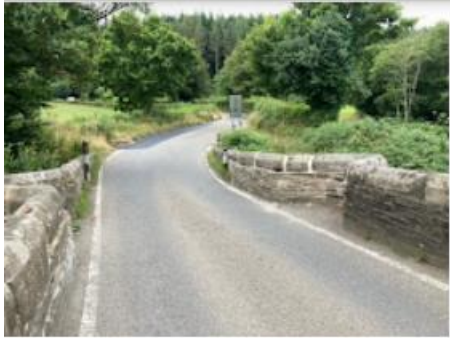
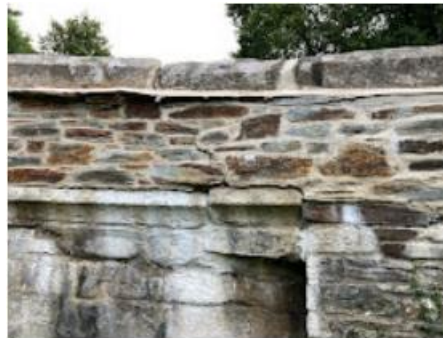
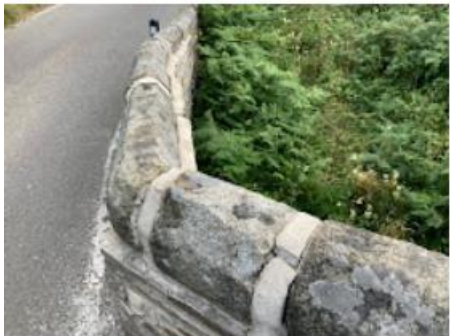
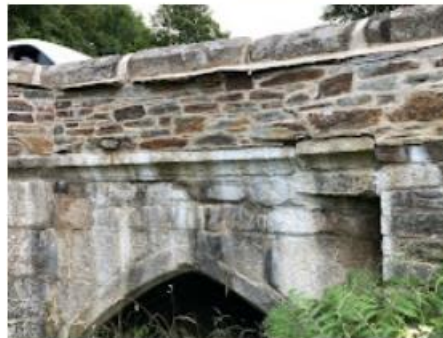
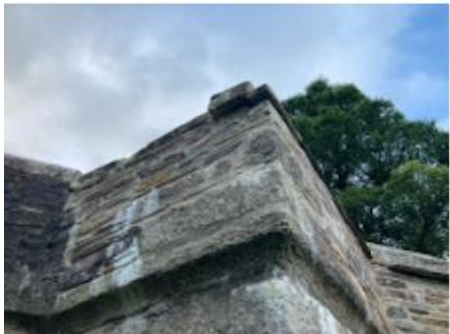
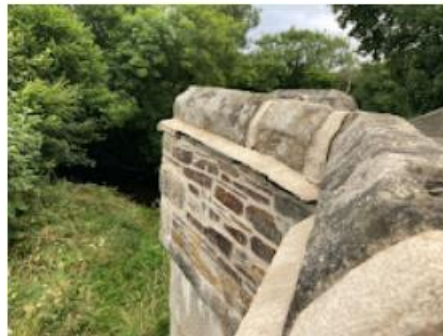
Photos: Robin Dyer

Trekelland Bridge (HER 6940; Listed Building (II*) 68430; SX 3004 7984; Lewannick parish) dating from the early 16th century is described on the HER as 'one of the best preserved and most beautiful of Cornish bridges'. The relentless damage being caused to it in modern times by motor traffic probably exceeds all the problems to its integrity in past centuries. Robin Dyer has examined the bridge recently and has noticed the impact of vehicles hitting it.

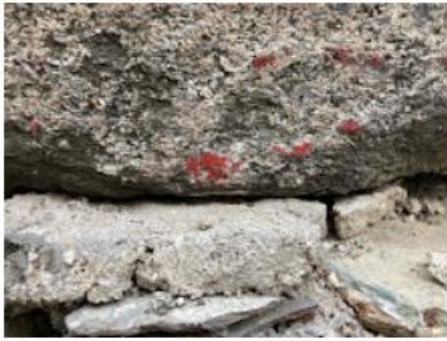
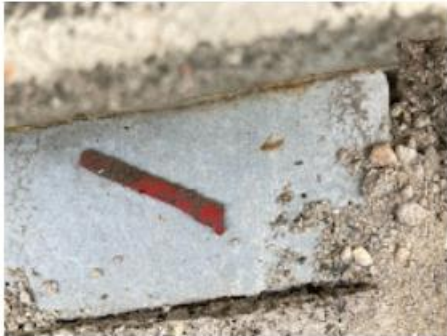
Photos: Robin Dyer

Cormac has repaired previous damage but Robin has shown that capstones have been dislodged and some cracks have appeared in the parapet on the upstream side. There are tell-tale hints about some vehicles that have caused this, including red paint. However, it is hard to prove exactly which red-painted vehicles are responsible.

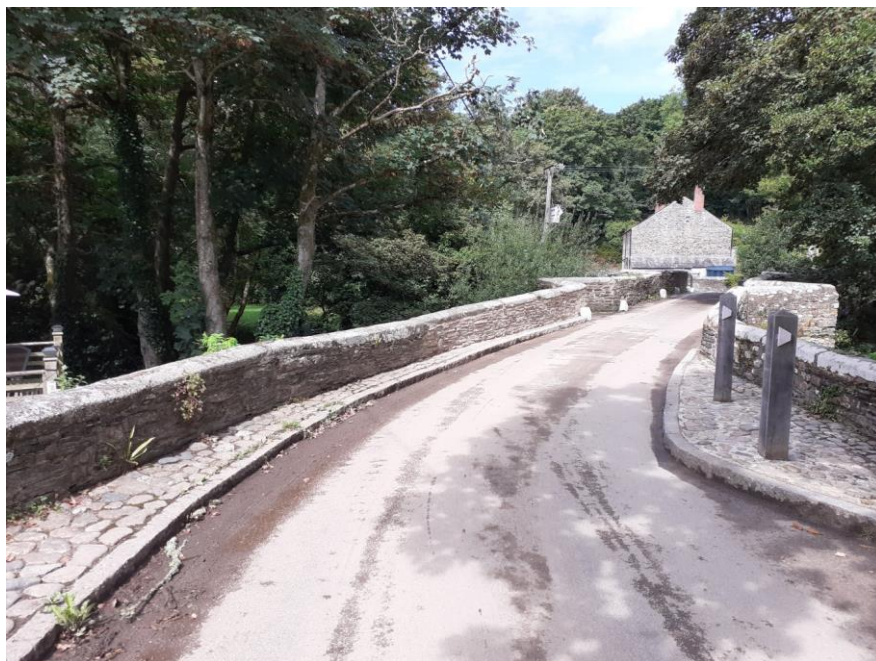
Other vulnerable bridges, like Ruthern Bridge (HER 26032 ;) Scheduled Monument 15576; Listed Building (II*) 67605; SX 0129 6682; Lanivet and Withiel parishes), which was damaged earlier in the year, have been repaired recently. Another casualty of the motor wars has been Helland Bridge (HER 17108; Scheduled Monument 1020812; SX 0652 7149; Helland and St Mabyn parishes). This has also been carefully repaired following a catastrophic hit last year, which is good news. Less pleasing news is that traffic has returned, much of it using the bridge as a short-cut between the A30 and B3226 roads.

Helland Bridge repaired – for now

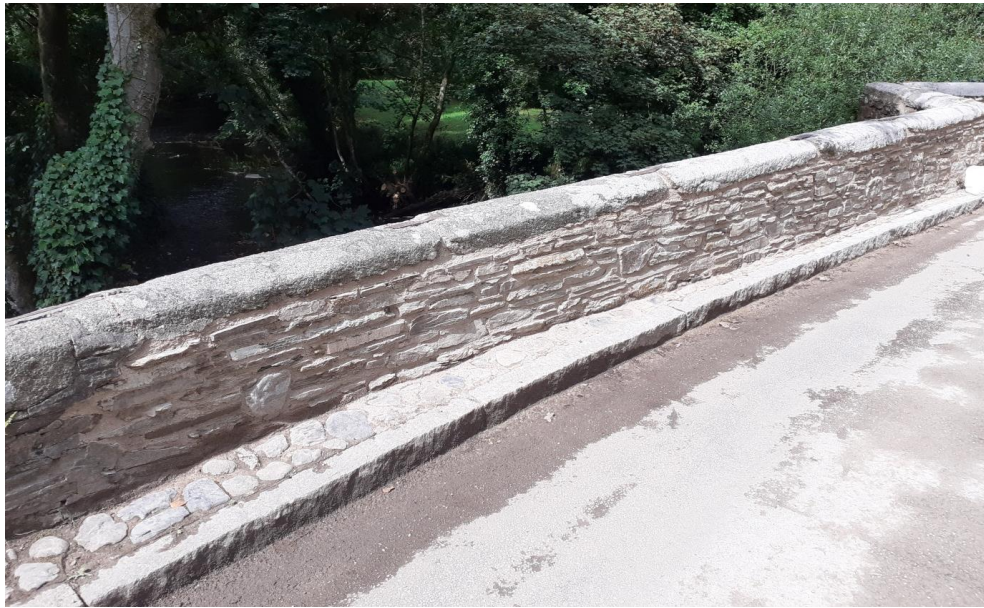
A neat job on Helland Bridge by Cormac.
