JANUARY 2022

Issue 62

SAVING ZENNOR QUOIT – OR WHO NEEDS HISTORIC ENGLAND?

NEWS FROM THE MILESTONE SOCIETY

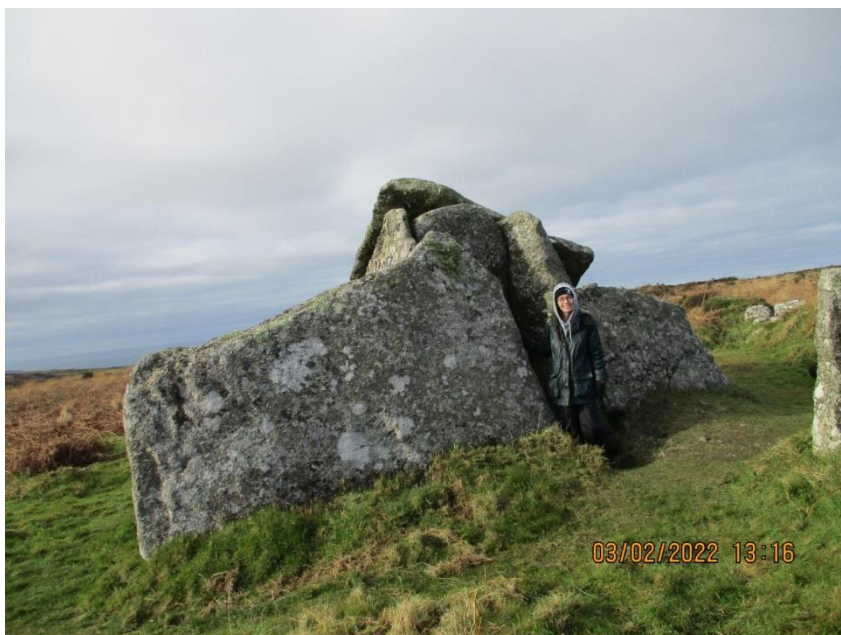
Photo: Adrian Rodda

It is a portal dolmen with an anti-chamber and two long wings. The one behind Anna Horigan has six drill marks along its top edge, while the bigger one (south pointing) looks to be untouched.

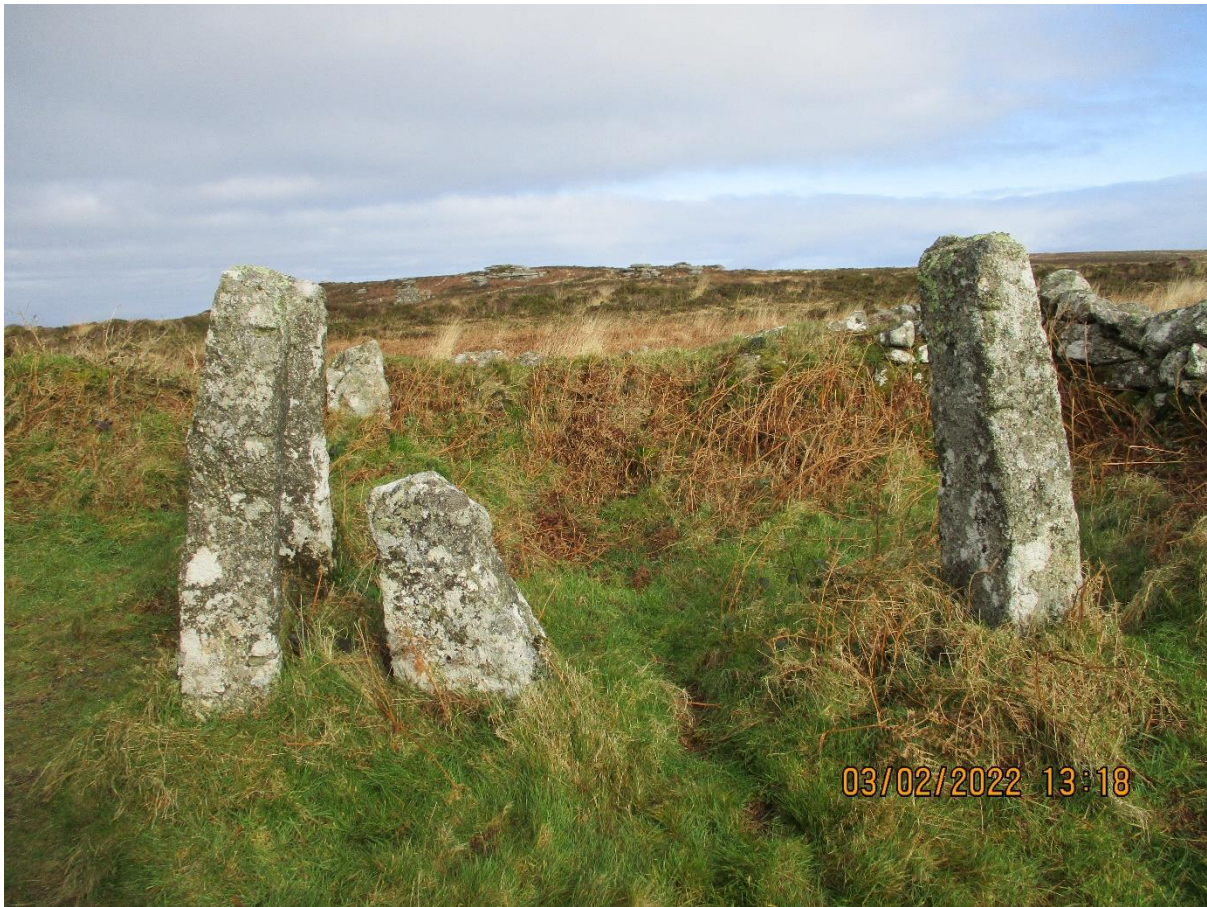
Photo: Adrian Rodda

The cowshed against the field hedge has 5 standing supports, one of which is truncated. The two taller ones in the front of the picture have obvious drill holes. We tested if either of them was snapped off the top surface of the portal wing. This was not the case. The wing had 6 drill holes and was 13.5 inches thick, while the supports had 3 visible drill holes each and tapered from 11.5 to 8.5 inches thick. Neither set of drill holes matched the distancing of those on the portal wing. However, they did match each other, so may have been another moorstone used to build the cowshed.

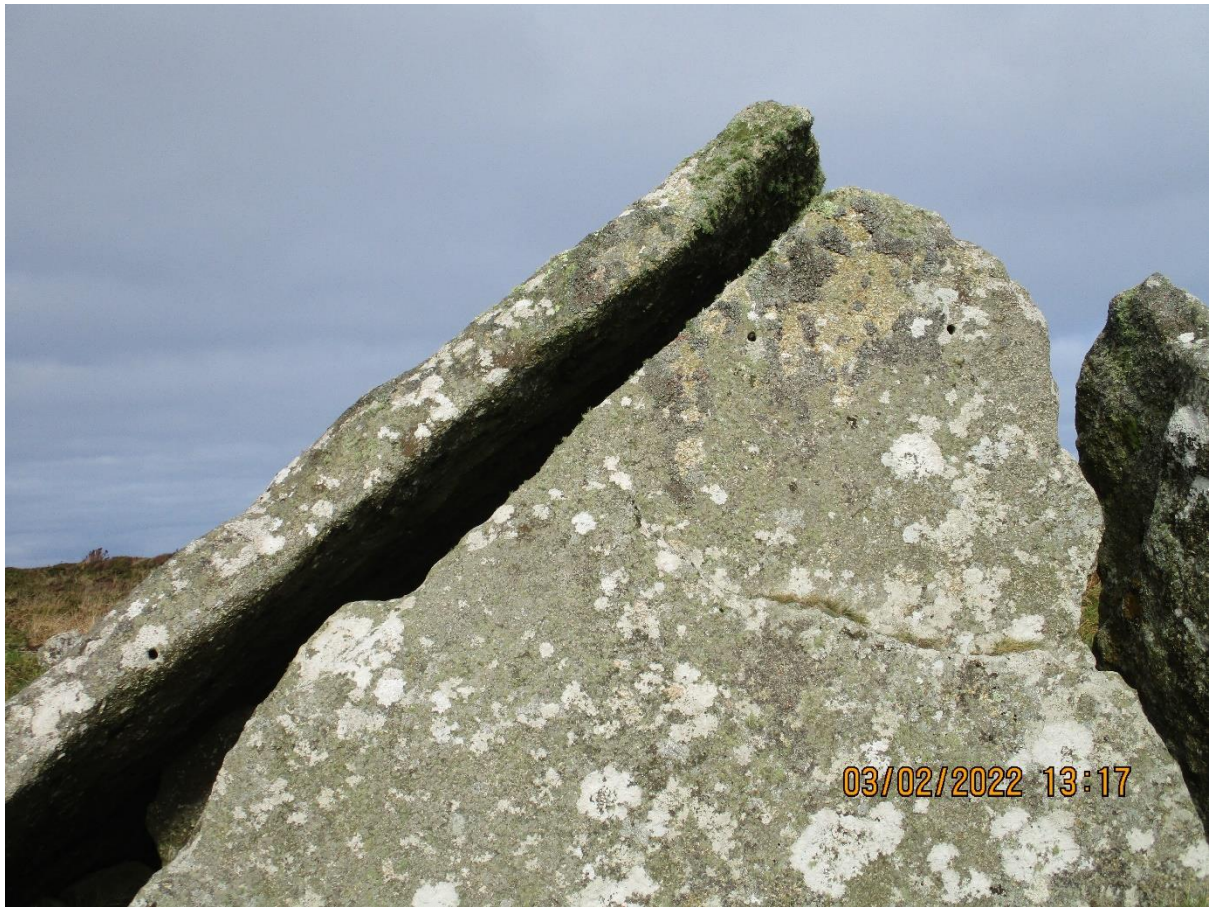
Photo: Adrian Rodda

The south side of the quoit tells an interesting story too. Two drill holes near the top of the support stone are each 3 inches deep and their termini are flat; they do not pierce the stone. The same is true of the one on the leaning capstone. It looks as though the farmer intended to use the long wing of the portal as a wall and extend a roof across, possibly leaning with the capstone. The top holes are difficult to reach, so I wonder if there was more of a remnant mound at the foot of the slab for him to climb on than there is now.

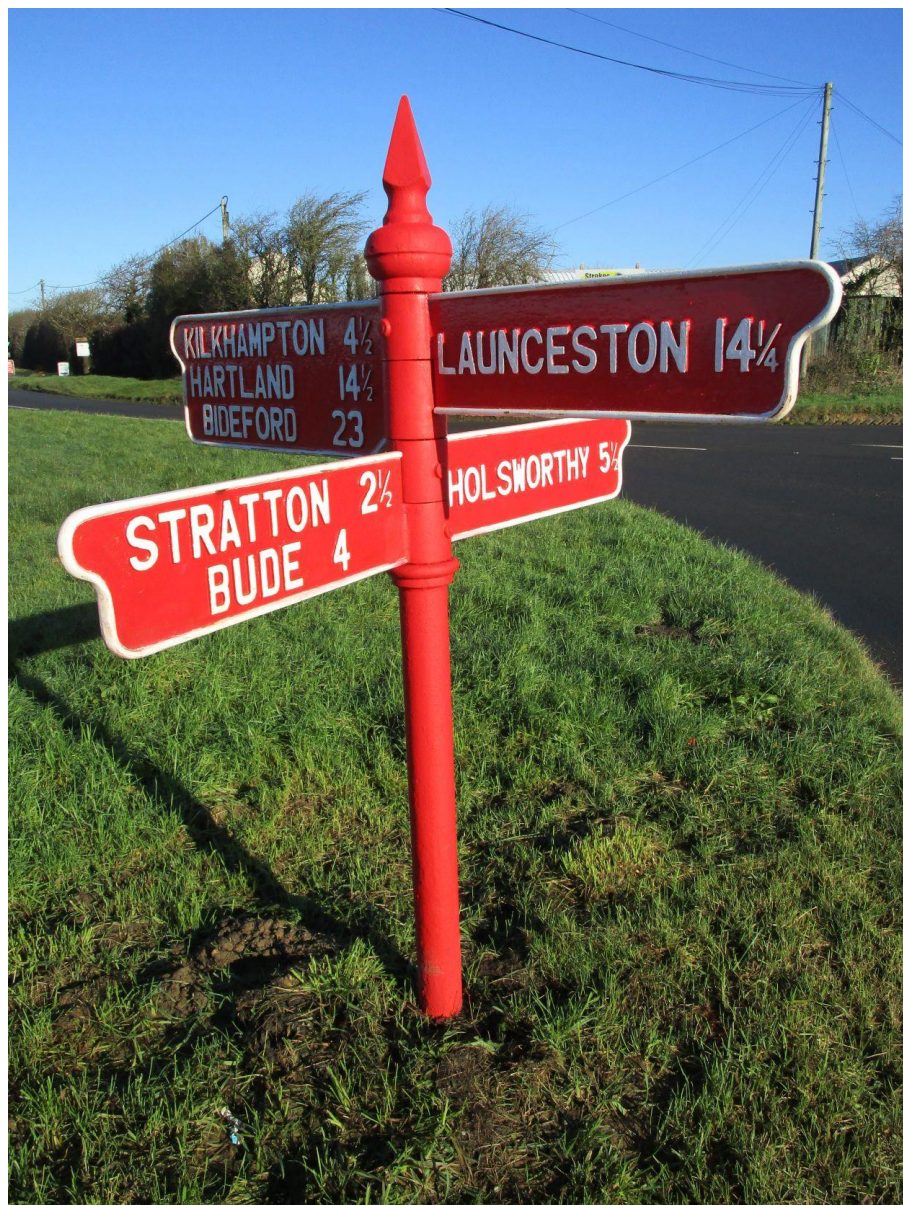
The red-painted fingerpost (HER 176673; SS264052; Launcells parish) at Red Post crossroads near Bude was in a sorry state last summer, because the four arms and the finial were stolen. The good news is that the local community raised the funds to have replacement arms and a finial cast at Irons Brothers foundry. The new parts were fitted by Cormac in November 2021, restoring this iconic landmark for all to enjoy. (Photo 1)

Photo 1: Red Post restored SS264052 A3072 Launcells
Photo: Ian Thompson

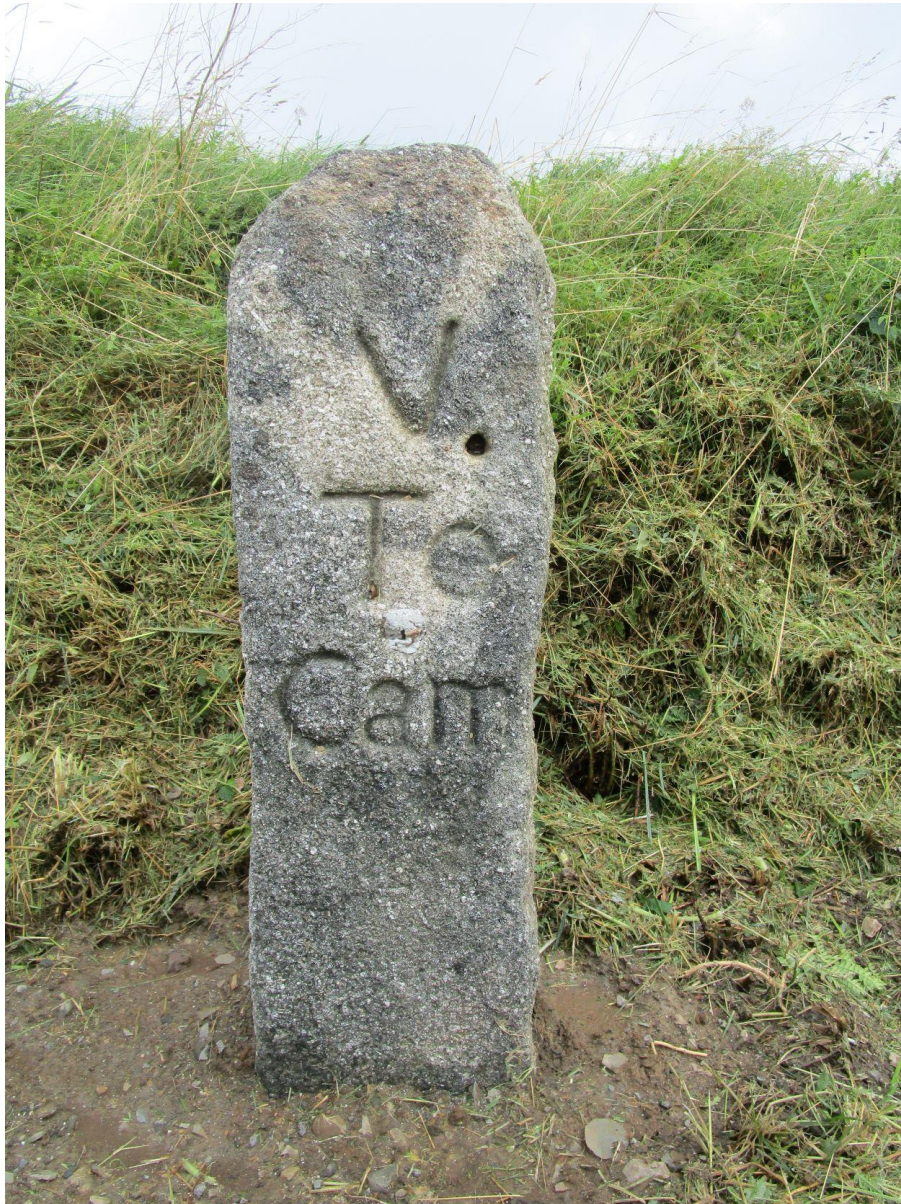
When a turnpike trust was set up by Act of Parliament, what did it do with pre-turnpike milestones on its road? A pre-turnpike milestone on the Launceston trust's road to Camelford ended up as a gatepost in an orchard. It was returned to its original roadside position on A395, thanks to the generous help of the orchard's owner and Cornwall Council's contractor, Cormac. This is one of four surviving milestones on the pre-turnpike road from Camelford to Launceston. (Photo 2)

Photo 2: Pre-turnpike milestone re-erected SX1712 8770 A395 Tresoke, Davidstow

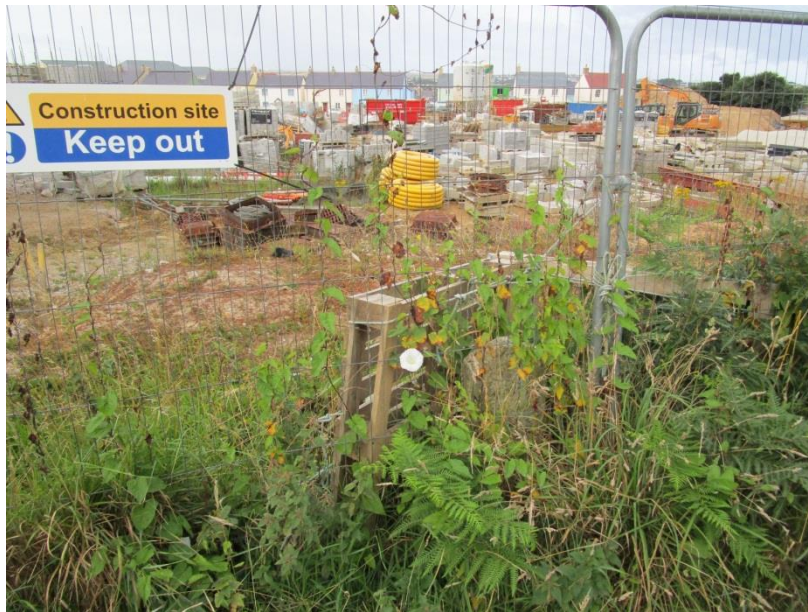
Nansledan is a huge greenfields housing development on the outskirts of Newquay, involving a number of building contractors under the umbrella of the Duchy of Cornwall. A rather small milestone (HER 172728; Listed Building (II) 71110; SW 839 617; Newquay parish) has been surrounded by continual building work for over three years. Fortunately, it was Grade II listed, so its location had to be considered at the planning stage and the new houses, school and shops built without disturbing it. In September 2021 it emerged at last from its protective wrapping of wooden pallets and the Milestone Society was called in to repaint it. (Photo 3 & 4)

Photo 3: SW839 617 A3058 Nansledan, Newquay August 2020
Photo: Ian Thompson

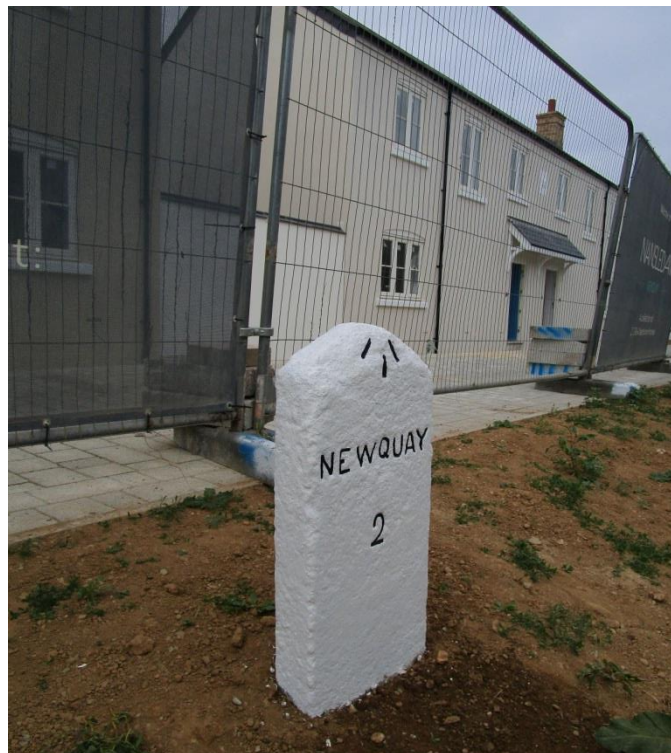
Photo 4: SW839 617 A3058 Nansledan, Newquay September 2021
Photo: Ian Thompson

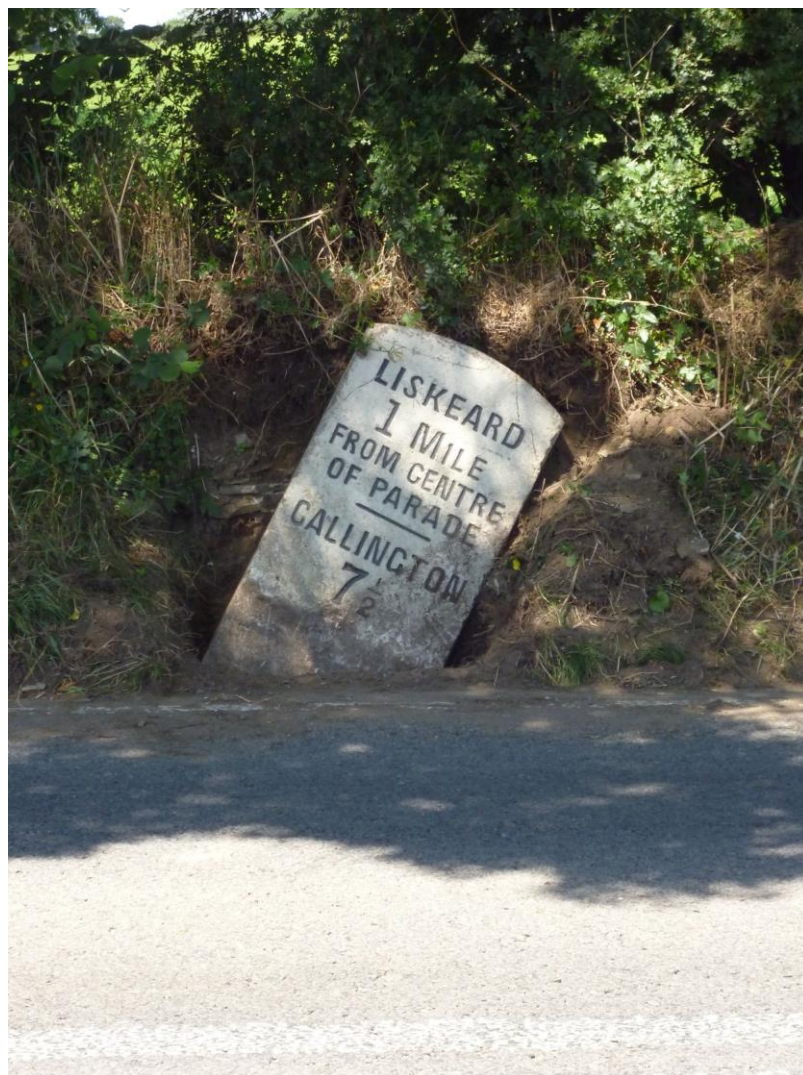
In 2019, Rosy Hanns surveyed 656 Cornish milestones and reported that 10 were fallen or leaning. In July 2021, the last of the 10 milestones was set straight (HER 172657; Listed Building (II) 382128; SX263655; Liskeard parish). It was in a narrow part of the busy road from Liskeard to Callington and had to wait for other nearby work requiring traffic lights to control the traffic to be scheduled, keeping the cost down.

Photo 5: SX263655 A390 Liskeard leaning 2014

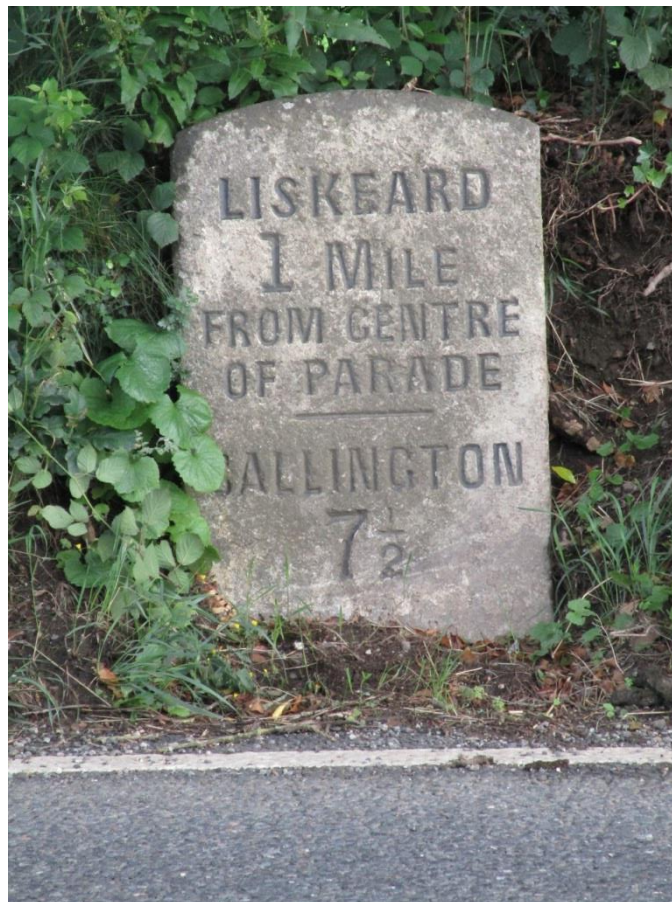
Photo 6: SX263655 A390 Liskeard set upright 2021

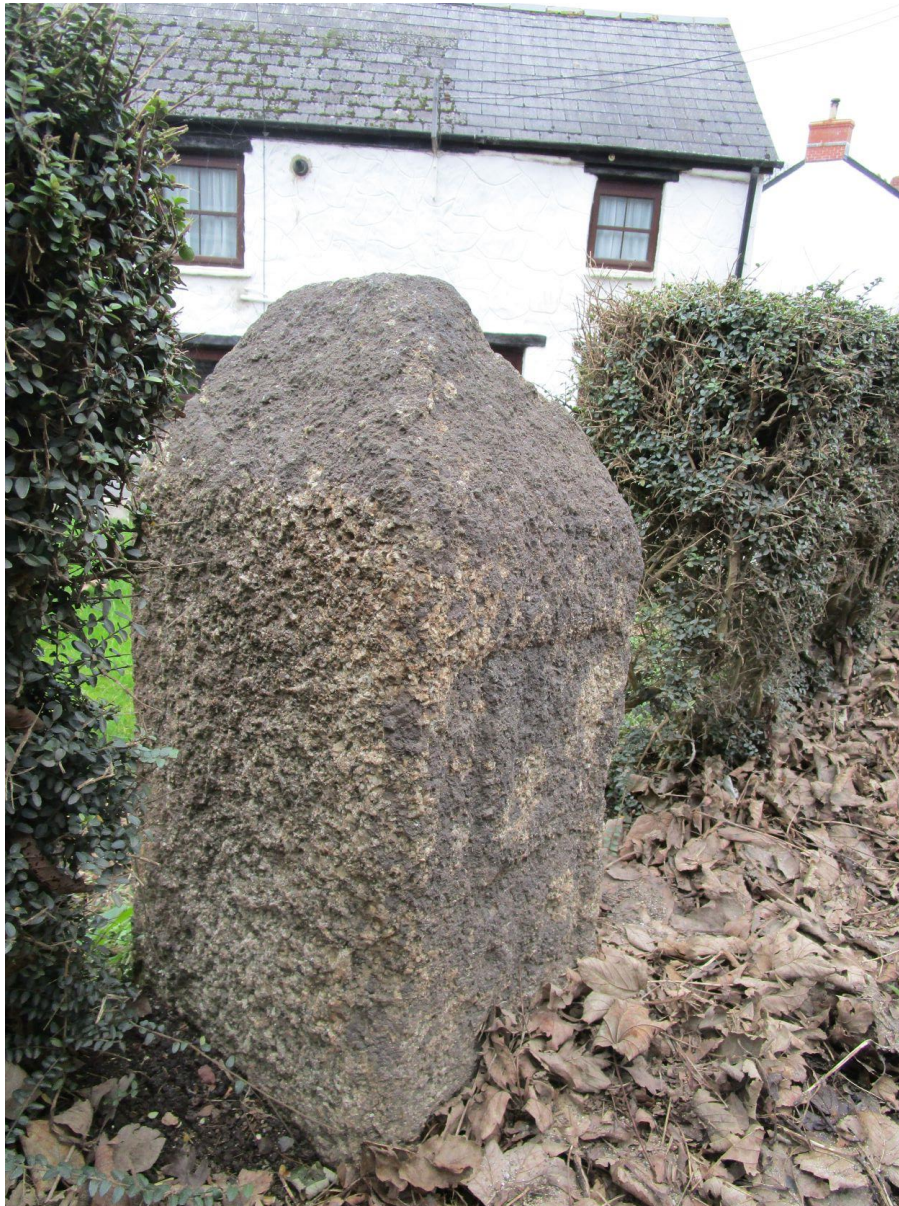
Oh, yes, it was! It had crossed the road and a bridge over a mill stream and now stood between neat privet bushes in front of an old stone cottage. It had lost its original position in road widening many years ago, but was safe now, just twenty yards away. The inscription in raised lettering reads L / 22 and P / 12. Ian had a nice chat to the old gentleman in the cottage, took some measurements and some photographs and rode home. (Photo 7)

Photo 7: Pre-turnpike milestone found SW61543 39679 Riverside, Roseworthy, Camborne

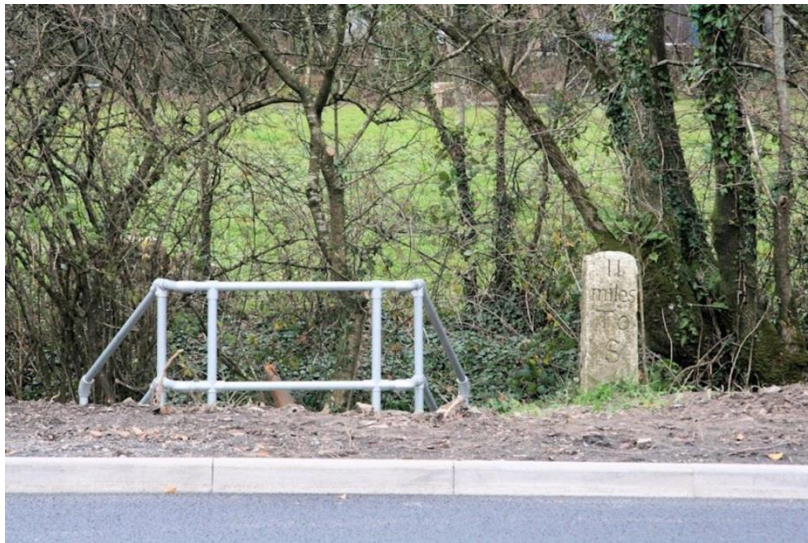
Two Milestone Society members in East Cornwall have been keeping an eye on the new development beside the road from Saltash to Callington. Peter Clements said ‘the intention is to build 1000 buildings - houses, a large nursing & residential home, a health and community centre, a primary school, etc.’ A new roundabout had been constructed within a few yards of a Grade II listed Saltash Turnpike Trust milestone (HER 172746; Listed Building (II) 60413; SX4122 6035; Saltash parish). Pete Goodchild saw that the milestone was in good condition, but had it been moved during the construction work? It seems that it may have been removed for protection during construction work, but was now back in its original position. Well spotted, both of you! (Photo 8 and 9)

Photo 8: SX4122 6035 A388 Carkeel Saltash. Photo Peter Clements 19.12.21
Photo: Ian Thompson

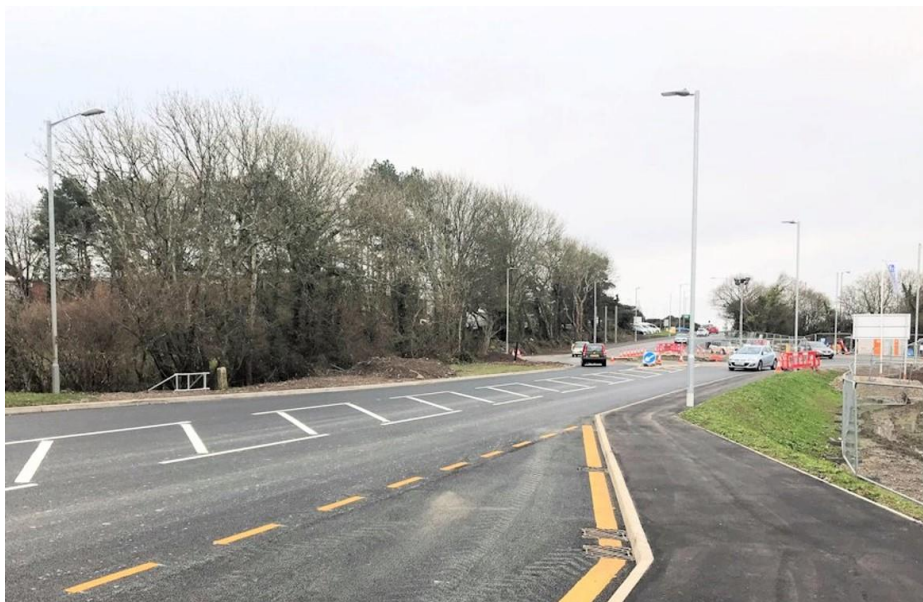
Photo 9: SX4122 6035 A388 Carkeel. Photo Peter Clements 19.12.21

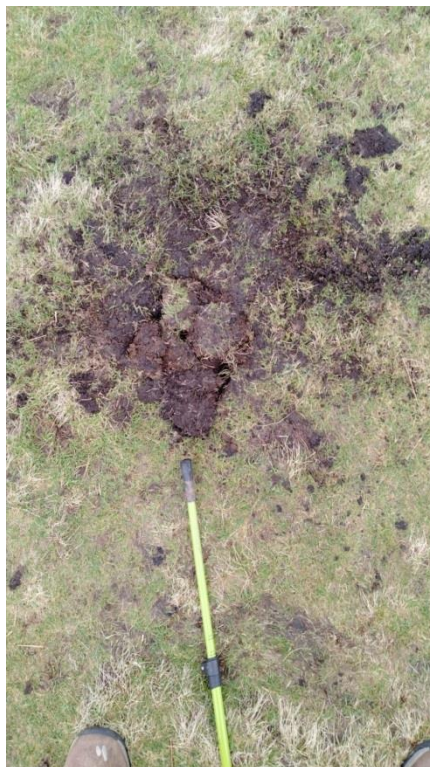
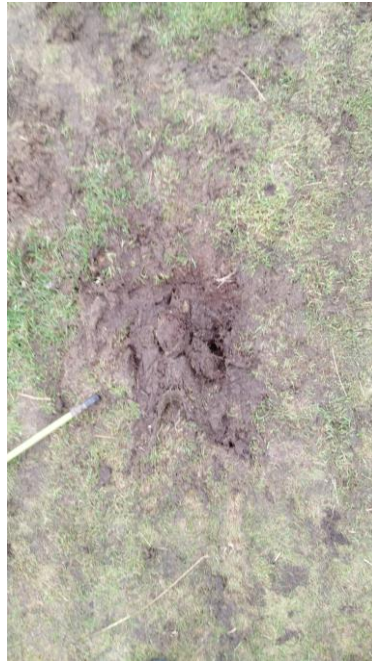
CAS received a report of a group of men using a metal detector in Stowe's Pound on Friday 21st January 2022. The next day the site was visited and the following photographs of digging were taken.
