MAY 2022

Issue 66

TRAUMA AT TREWORNAN

Trewornan Bridge – Another bridge closure

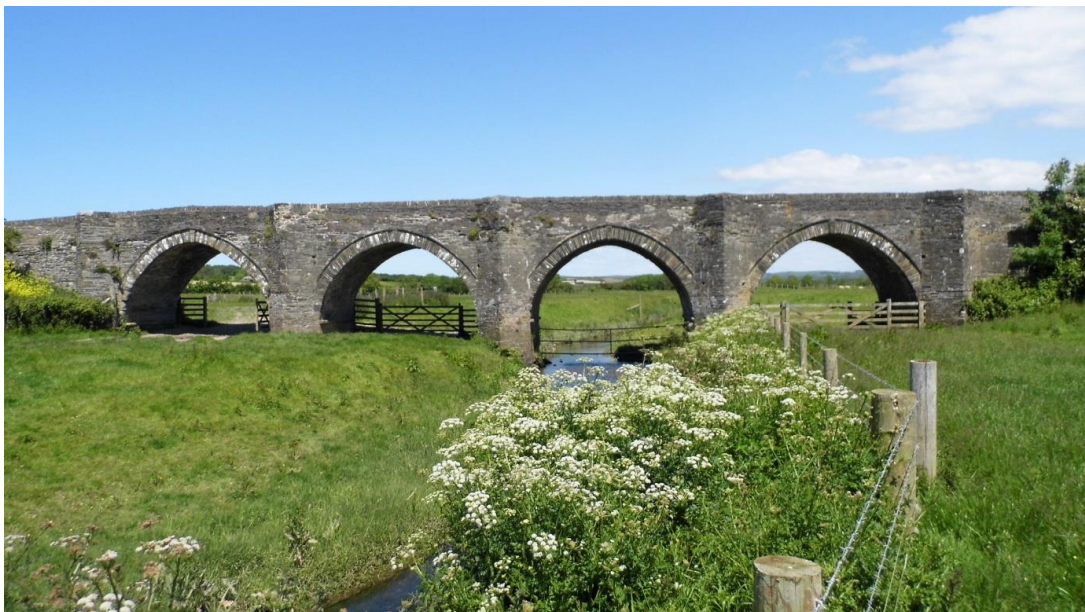
Downstream view of Trewornan Bridge in 2015

The four-arched bridge at Trewornan carries traffic across the Amble River and salt marshes of the broad valley on the B3314 road from Wadebridge towards St Minver at NGR SW 9874 7428. The bridge also links the parishes of Egloshayle on the south-east bank with St Minver on the north-west; it takes its name from the Domesday Manor of Trewornan, now an 18th century country house on the St Minver side of the river.

The four slightly-pointed arched bridge is built of rubble stone and consists of five piers with cutwaters on either side and pedestrian refuges above. The voussoirs of the arches are built of dressed slate stone and have a chamfered string course following the line of each voussoir on both the upstream and downstream sides. The piers also have horizontal string courses at the impost levels on either side, from which the arches spring.

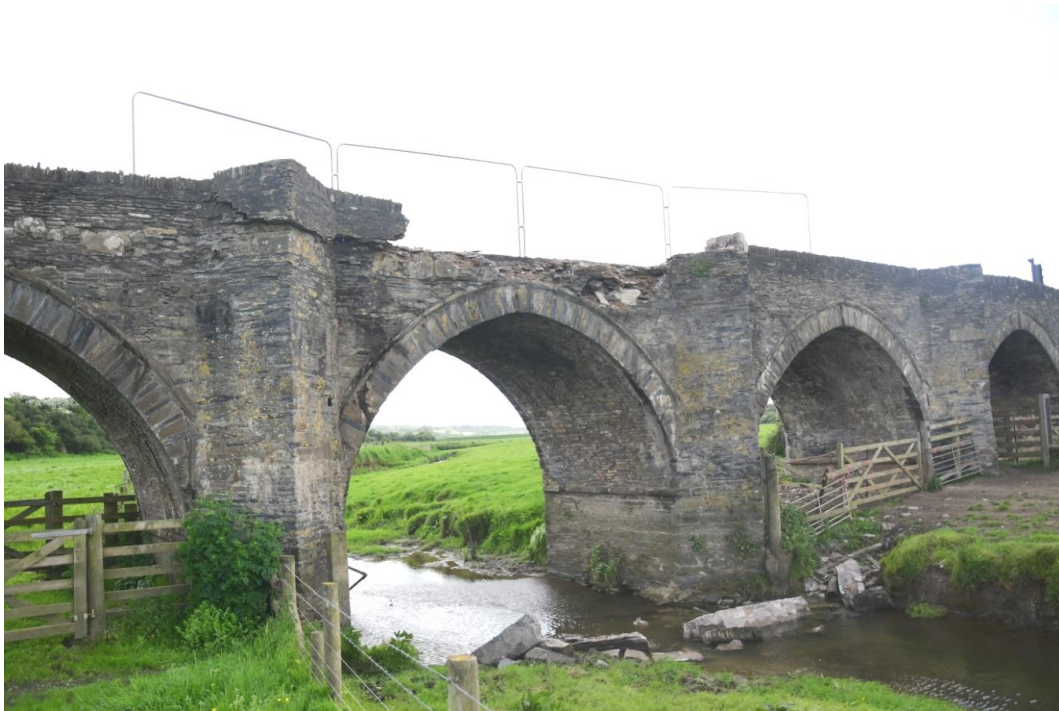
Upstream view of Trewornan Bridge showing large section of parapet missing

Local people have suggested that the vehicle which damaged the bridge was a road sweeper, although this has not been confirmed. The vehicle appears to have been travelling from the Wadebridge end of the bridge and came in contact with the upstream parapet wall above the first arch, between the first and second pier. Here the parapet wall has been scraped throughout its length, some 6.1M (20ft), leaving a crack between the wall and the deck of the road, while the upper part of the wall, which is finished off with pitched stone, also has fine cracks in it.

The bridge was inspected and deemed to be structurally unsafe for vehicles and was closed on Sunday 15th May until further notice.

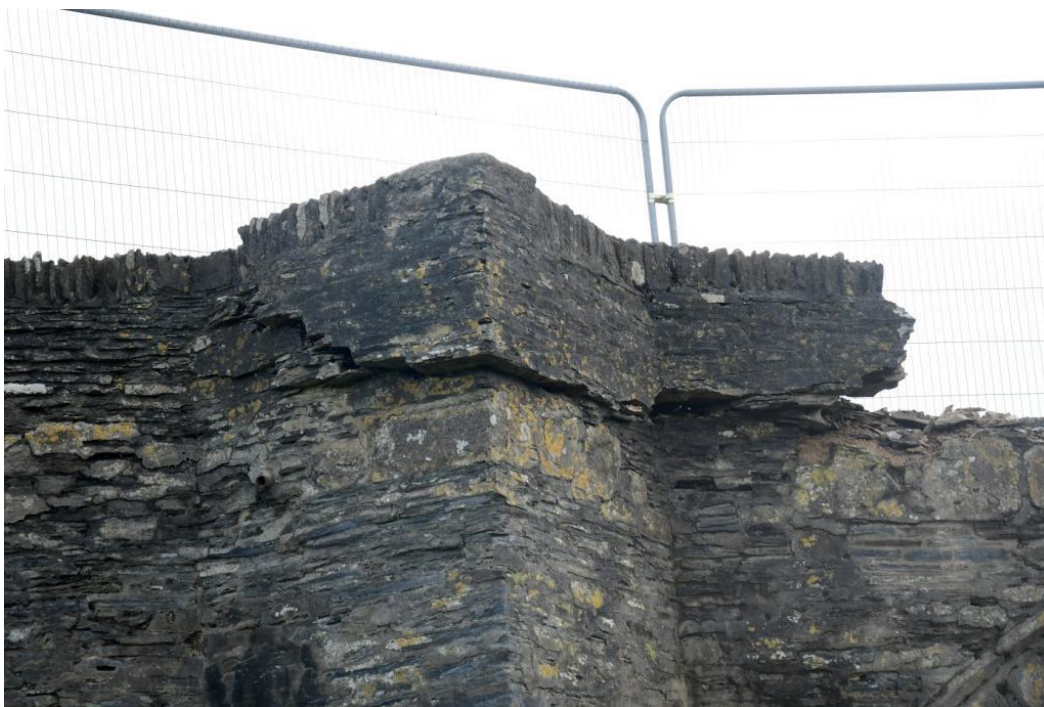
Wall of pedestrian refuge hanging over the edge of the bridge

The vehicle then hit the second refuge wall, leaving it hanging over the edge of the bridge and completely destroyed the parapet wall above the second arch, between the second and third pier including the third refuge, all the stonework being pushed over and down into the Amble river, a length of approximately 11M (36ft). The parapet wall over the second arch has also been damaged below the level of the parapet wall, right down the voussoir and taking out part of the spandrel wall.

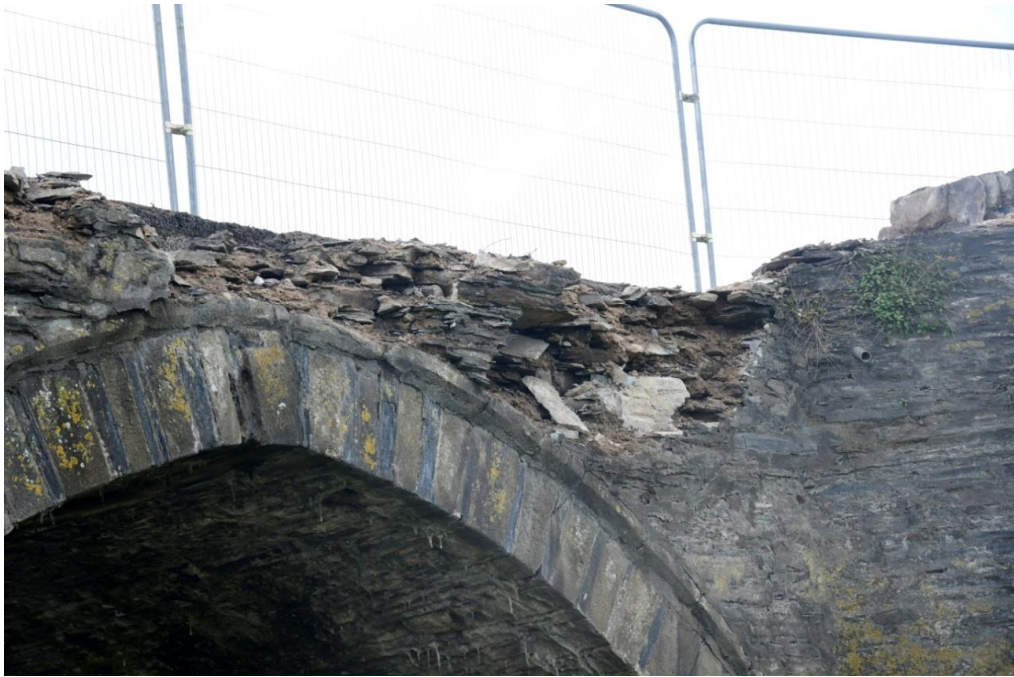
Damage to the spandrel wall as far as the voussoir

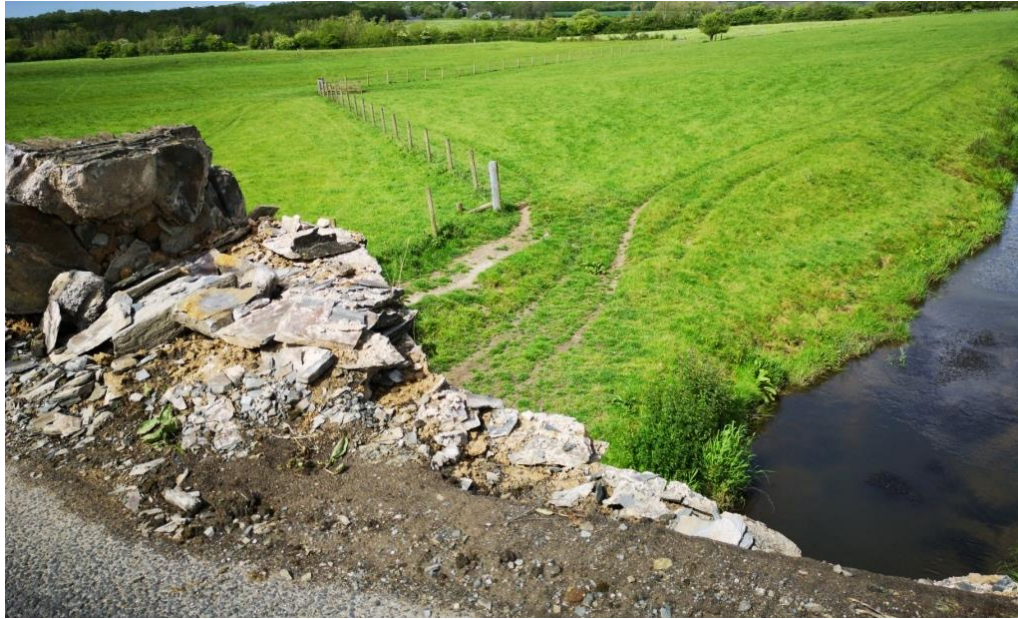
Demolished pedestrian refuge and parapet wall. Photo: Adrian Langdon

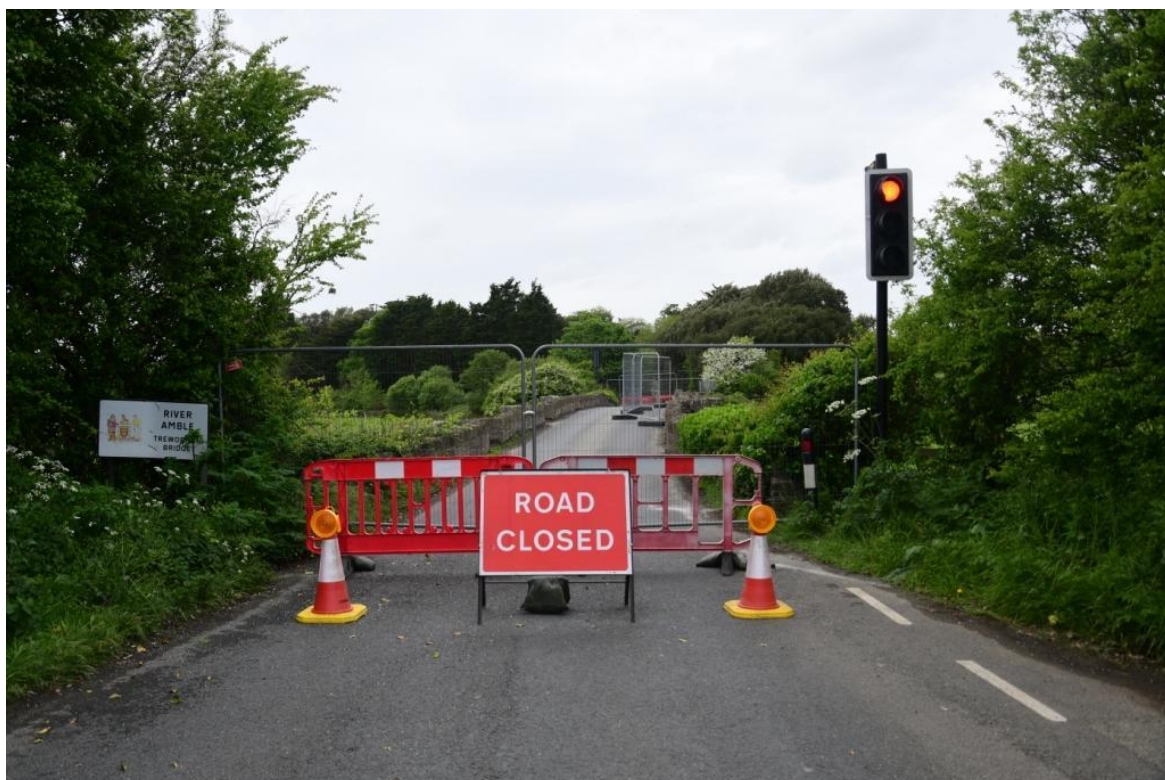
Trewornan Bridge closed. Photo: Adrian Langdon

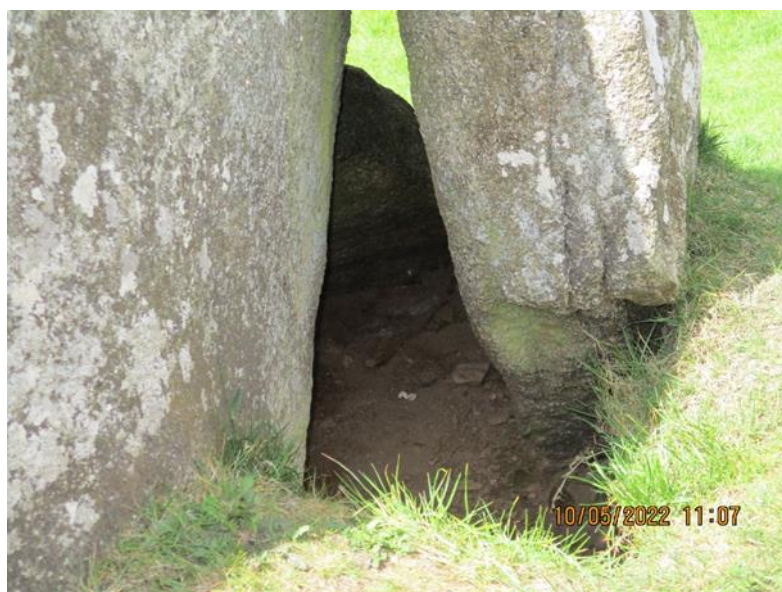
On 10th May I took an artist friend up to gain some inspiration from the dramatic prehistoric monuments in the Minions area. After King Doniert's Stone we sought out Trethevy Quoit, the biggest and most impressive dolmen in the Duchy [HER 17337; Scheduled Monument 15003; SX 2593 6881; St Cleer parish]. All was not well. Someone had been digging the floor of the chamber and widened access to it through the portal stone's "doorway" by digging away the soil on the support side and exposing more of the base of the support.

You can see from this photograph how much lower the floor of the chamber is than the remnant of the mound outside it. More worrying is the exposure of more of the once buried support, which is traced in the colours. An area of green algae sits above a soiled area, presumably recently covered in earth.

That evening I alerted EH, CHT, HER, Andy Jones of CAU, Uncle Tom Copley and all. All replied the next day. Apparently EH and CHT were sending a work party to address erosion at the monument and at the Hurlers. Both activities required Historic England consent, which had been obtained for 31st May and 1st June.

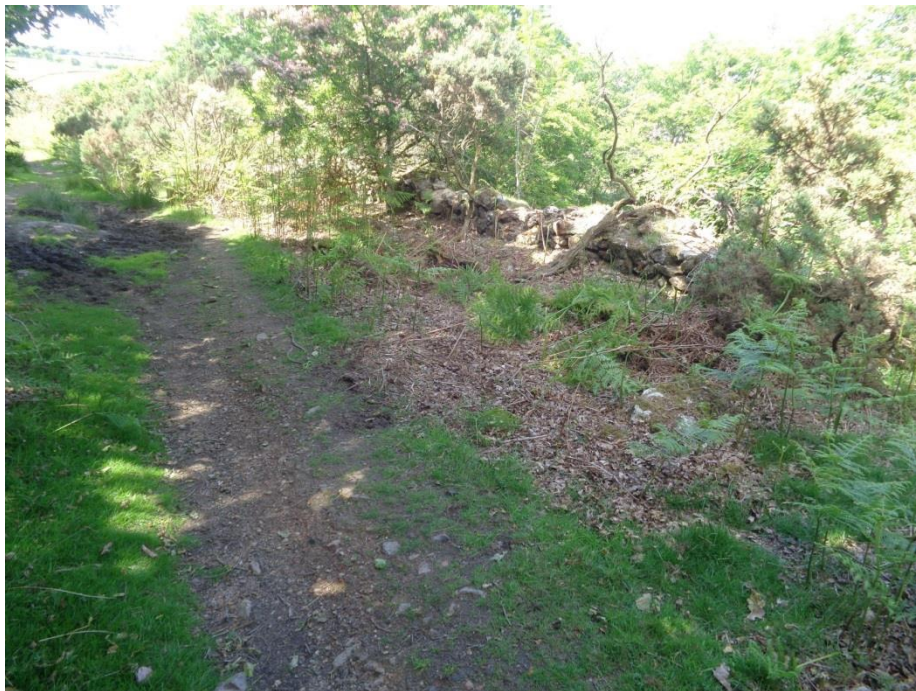
From the Marke Valley Branch of the L. & C.R. only the top 0.5m on the South wall can be seen. Photo: Brian Oldham

On further investigation the size of the store remains come as a surprise as all that can be seen from the disused rail track is the top 0.5m of the South wall, often missed completely when the bracken is high. This is the point where the railway wagons would stop and be unloaded in to the store at roof level possibly by a chute or winch mechanism. A short

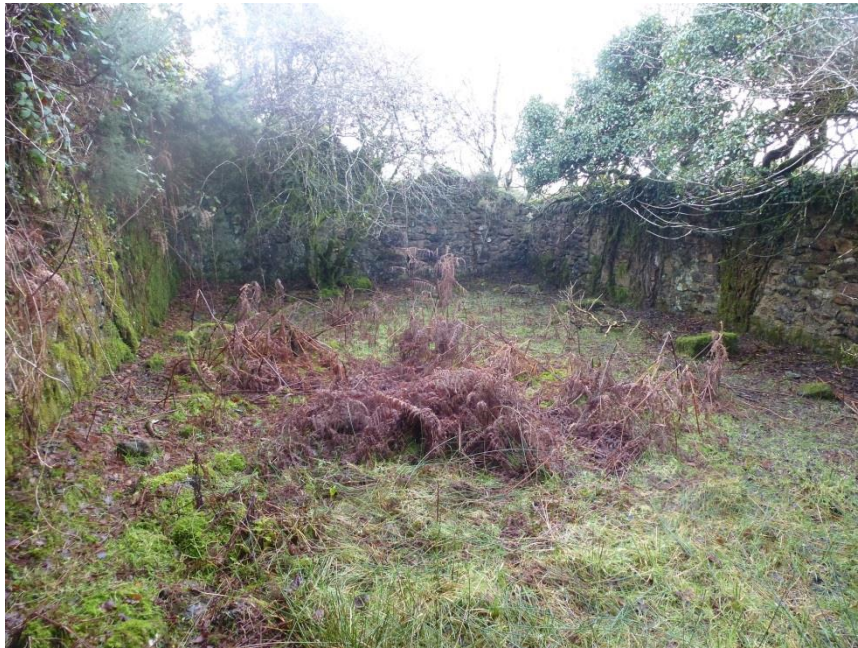
scramble down the railway embankment reveals that that South Wall is in fact 3.3m high and store measures 12.8m x 7m with walls 0.5m thick.

The size of the store comes as a quite a surprise after scrambling down the bank. Photo: Brian Oldham

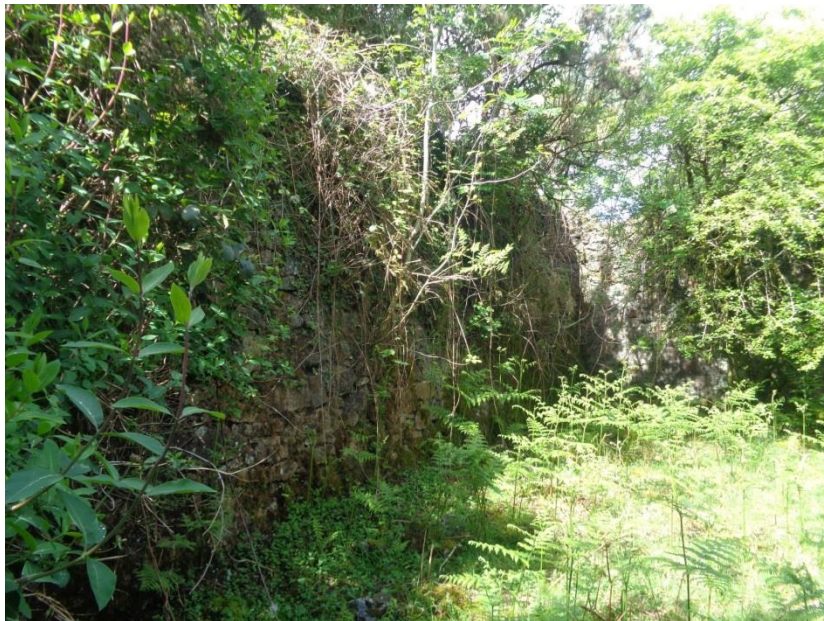
Internal side of the South wall revealed to be 3.3m high. Photo: Brian Oldham

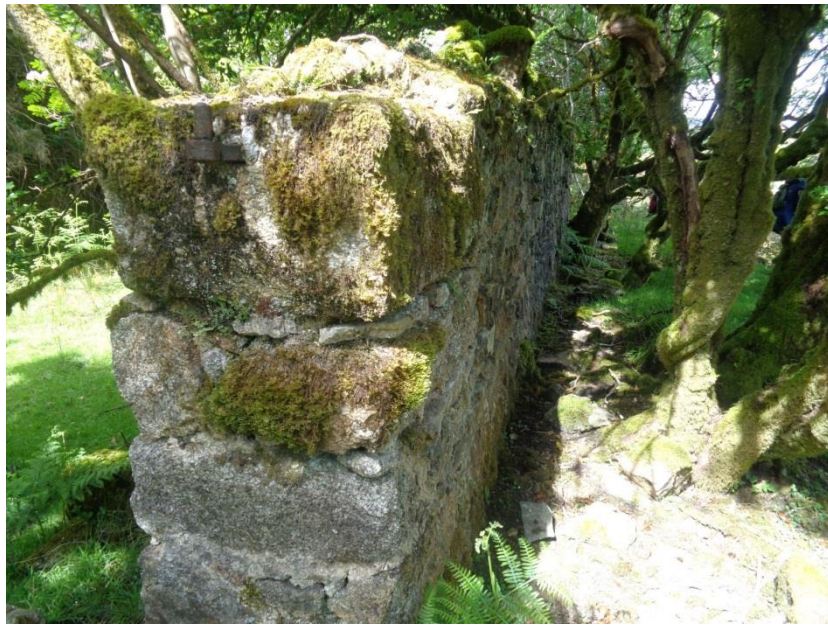
The side walls slope down to meet the 1.8m high North wall suggesting the possibility of a sloping roof. A gap in the North East corner, where metal gate hinges protrude from the ends of North and East walls, was the location of the gated or doored entrance. A line of granite blocks averaging 0.6m x 0.35m and 0.2m above ground may have been used to keep goods off the often damp earth, there is no evidence of a man-made floor.

0.5m thick North wall showing metal gate hinge. Photo: Brian Oldham

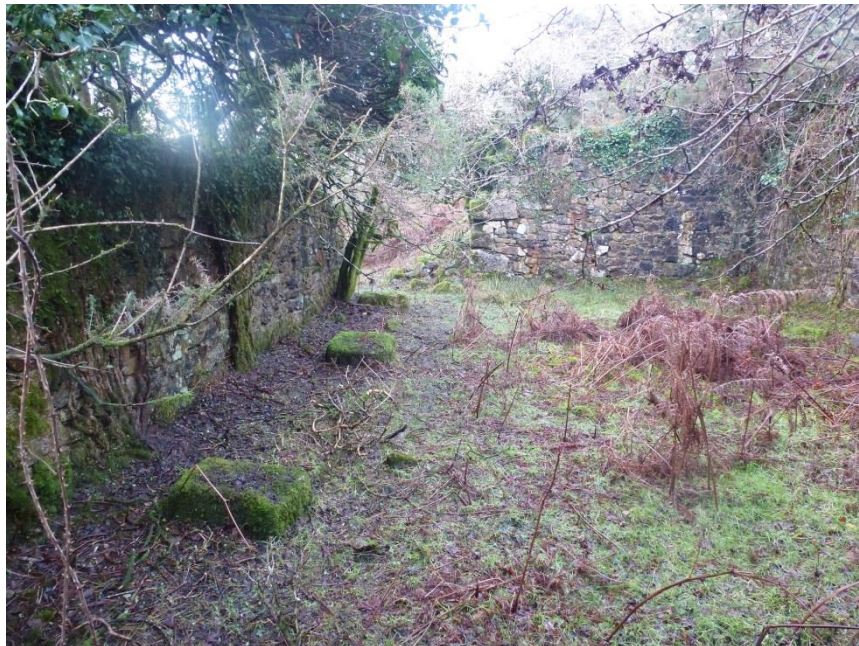
Line of granite blocks possibly to keep goods off the unmade floor, showing the North Easy corner entrance. Photo: Brian Oldham

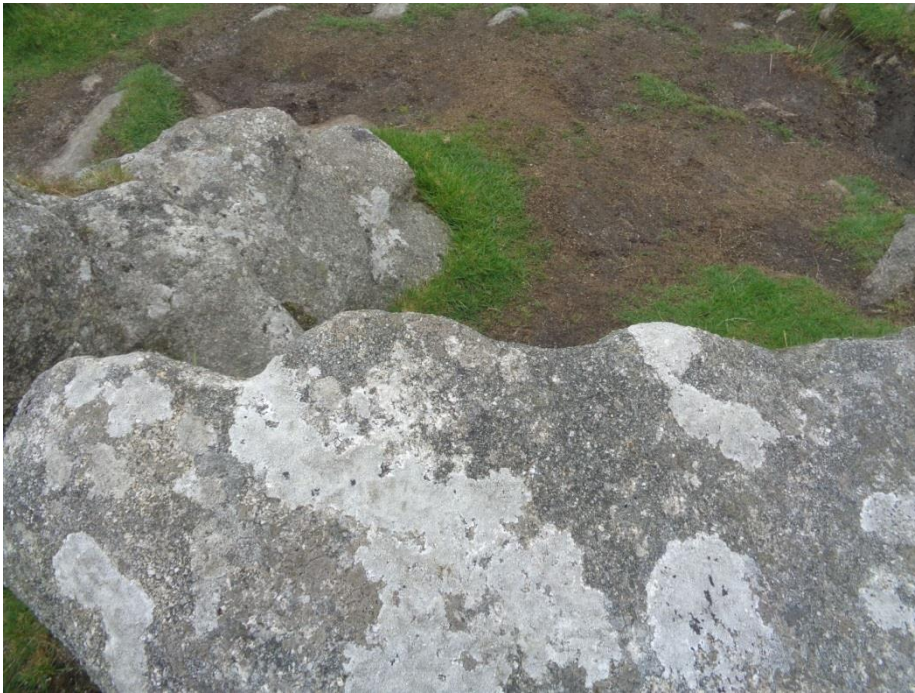
Evidence of wedge and groove granite splitting on Rough Tor

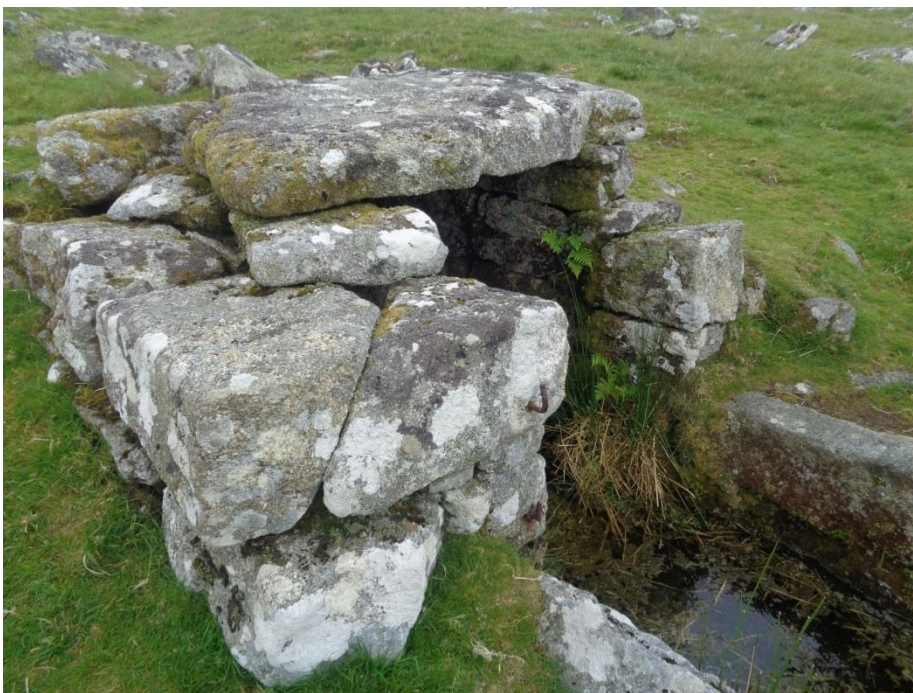
Door hinge on the Holy Well below Little Rough Tor
